TITLE	:	Report on the evaluation of the proposed P&H Rocklite® Class F (452 x 652 Glazing) Fire Door assembly when classified in accordance with SANS 1253
REQUESTED BY	:	P&H Protective Plaster Systems (Pty) Ltd PO Box 11845 ASTON MANOR 1630
CONTRACT No	:	FTC 23/061
ISSUE No	:	1
DATE	:	01 September 2023

This report contains the evaluation of the proposed **P&H Rocklite® Class F (452 x 652 Glazing) Fire Door** when classified in accordance with **SANS 1253: Fire-doors and fire-shutters**.

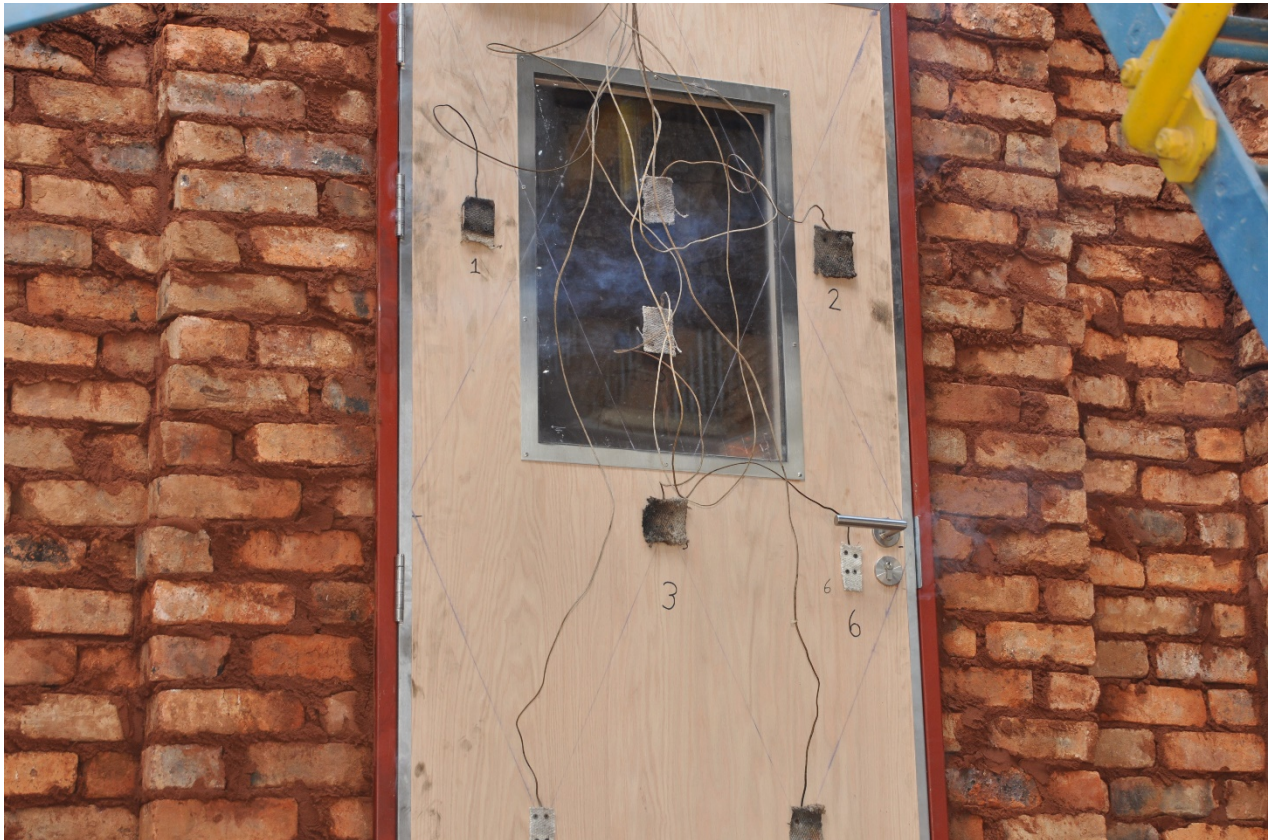
TIME (hh:mm:ss)	DESCRIPTION
00:00:00	– Test Started –
00:05:07	Light smoke release on left and right perimeters
00:05:41	Light smoke release from top perimeter

Figure 4.2.3: Light smoke release from left and right perimeter

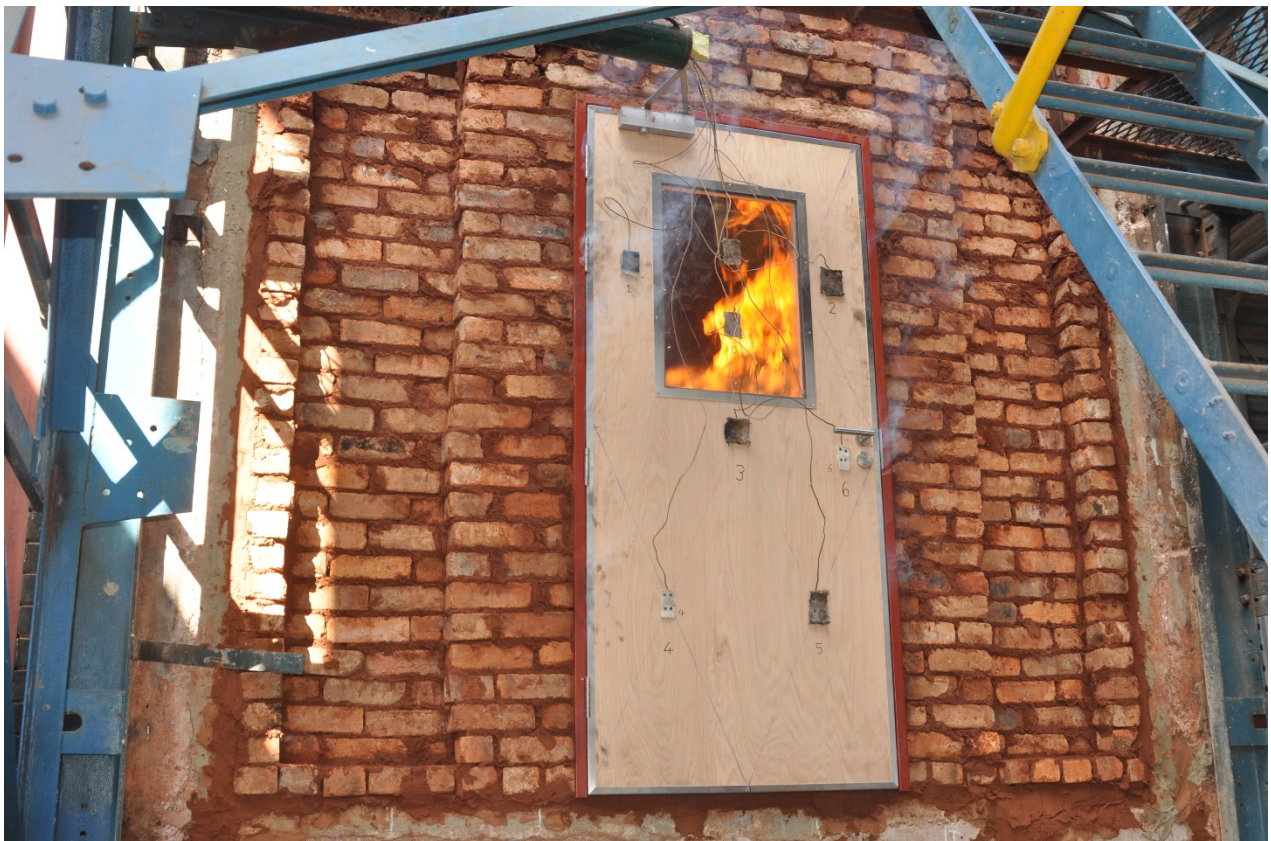
00:06:08	Door surface aflame inside furnace
00:06:33	General smoke release increase
00:07:14	Smoke release from sides of glazing (view panel)
00:07:45	Flaming stopped inside furnace

Figure 4.2.4: Door surface aflame inside furnace

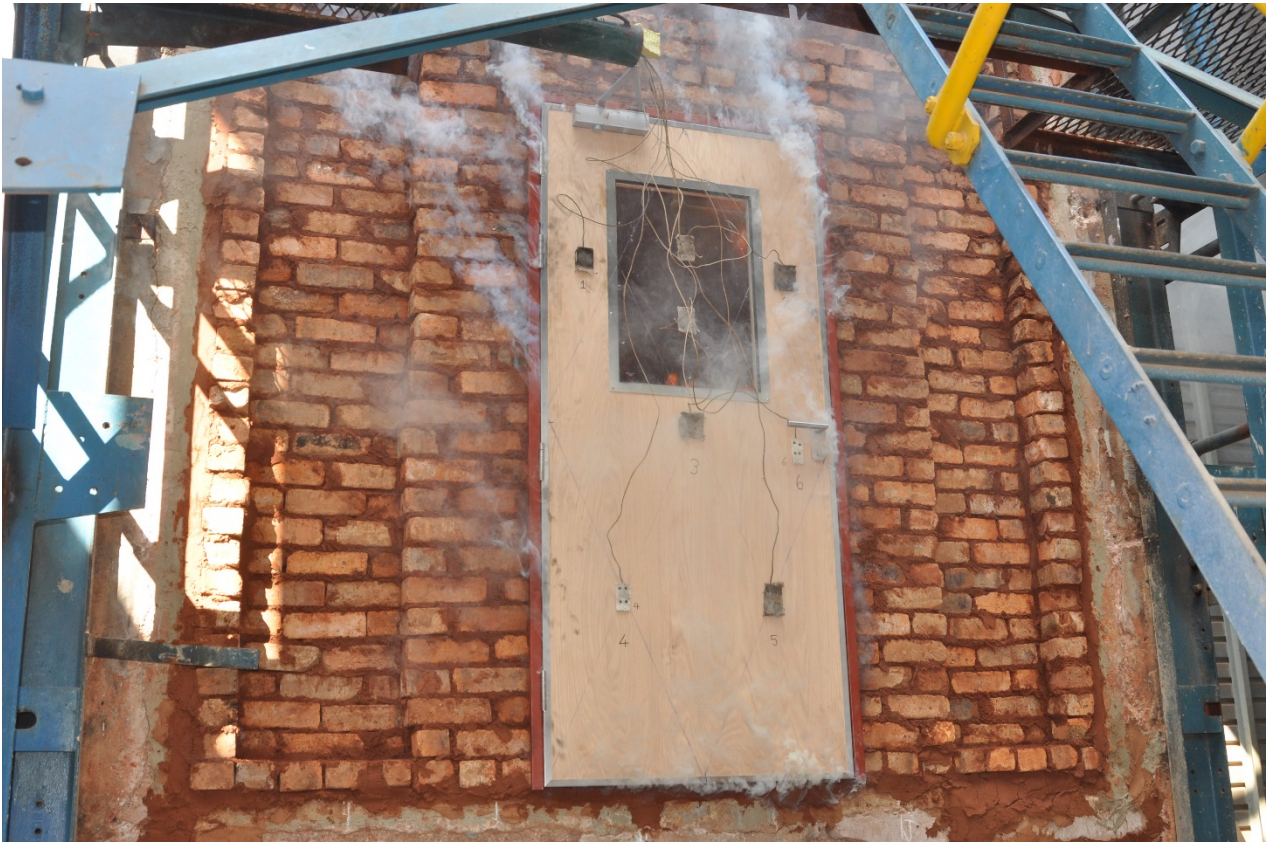
Figure 4.2.5: General smoke release increase

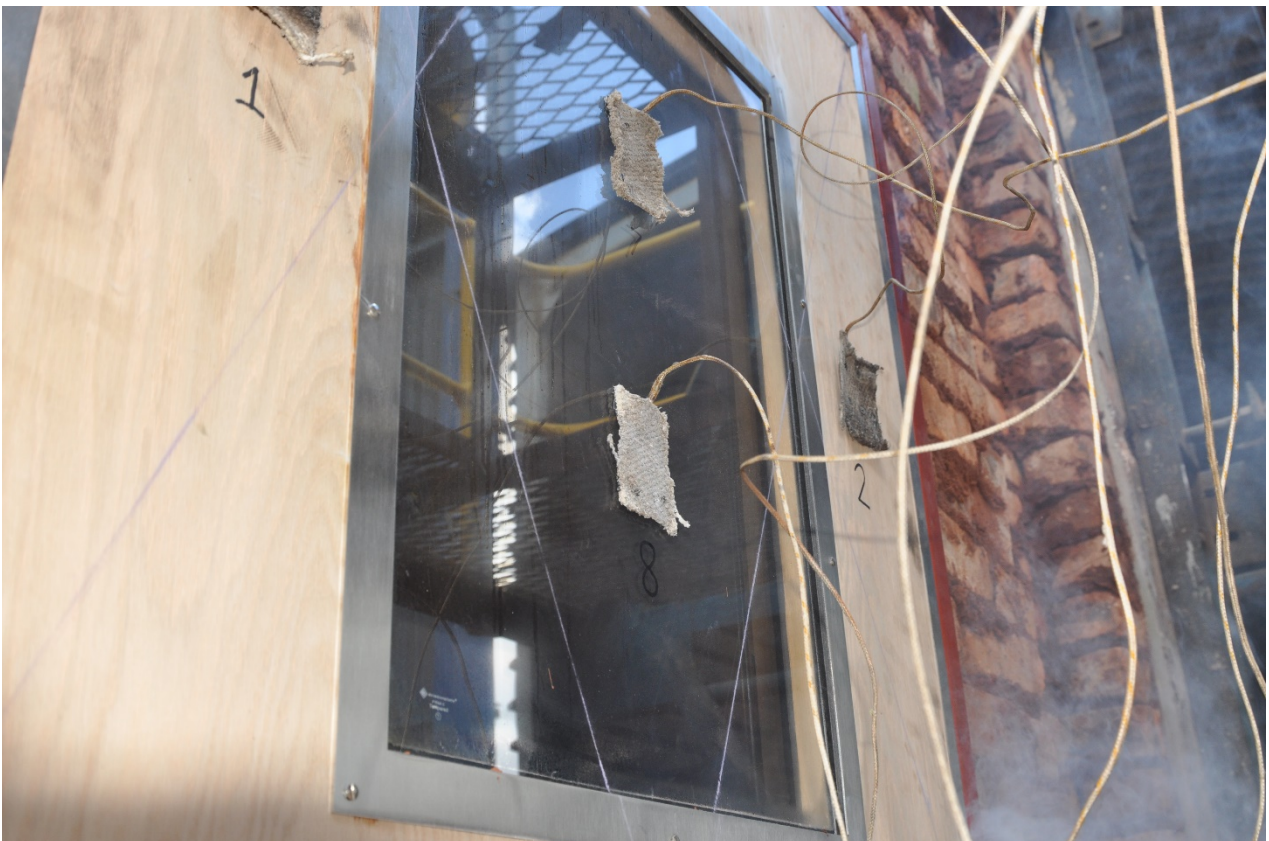
00:08:42	Glass inside darkening
00:10:47	Discoloration at right top corner and left of glazing (view panel)
00:11:46	Discoloration on bottom perimeter and lockset

Figure 4.2.6: Glass darkening

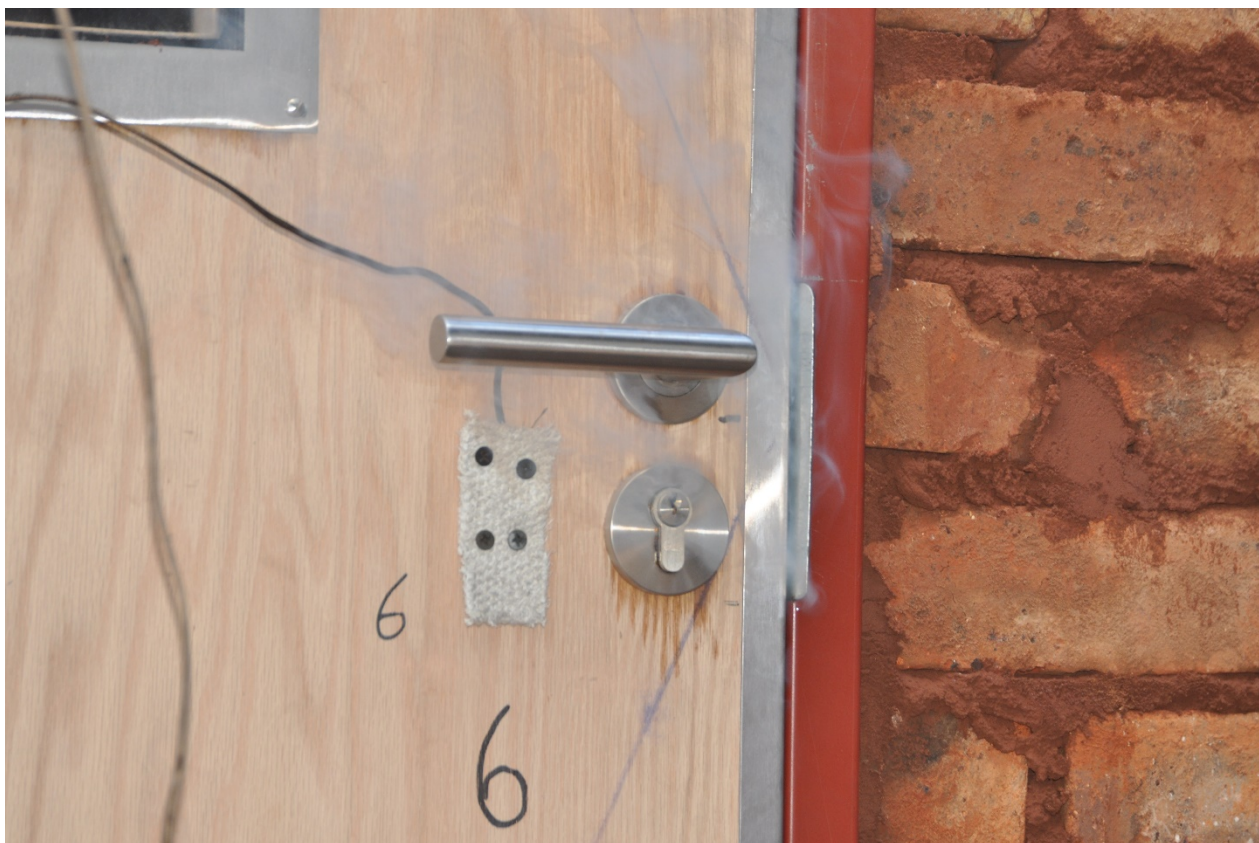
Figure 4.2.7: Discoloration at lockset

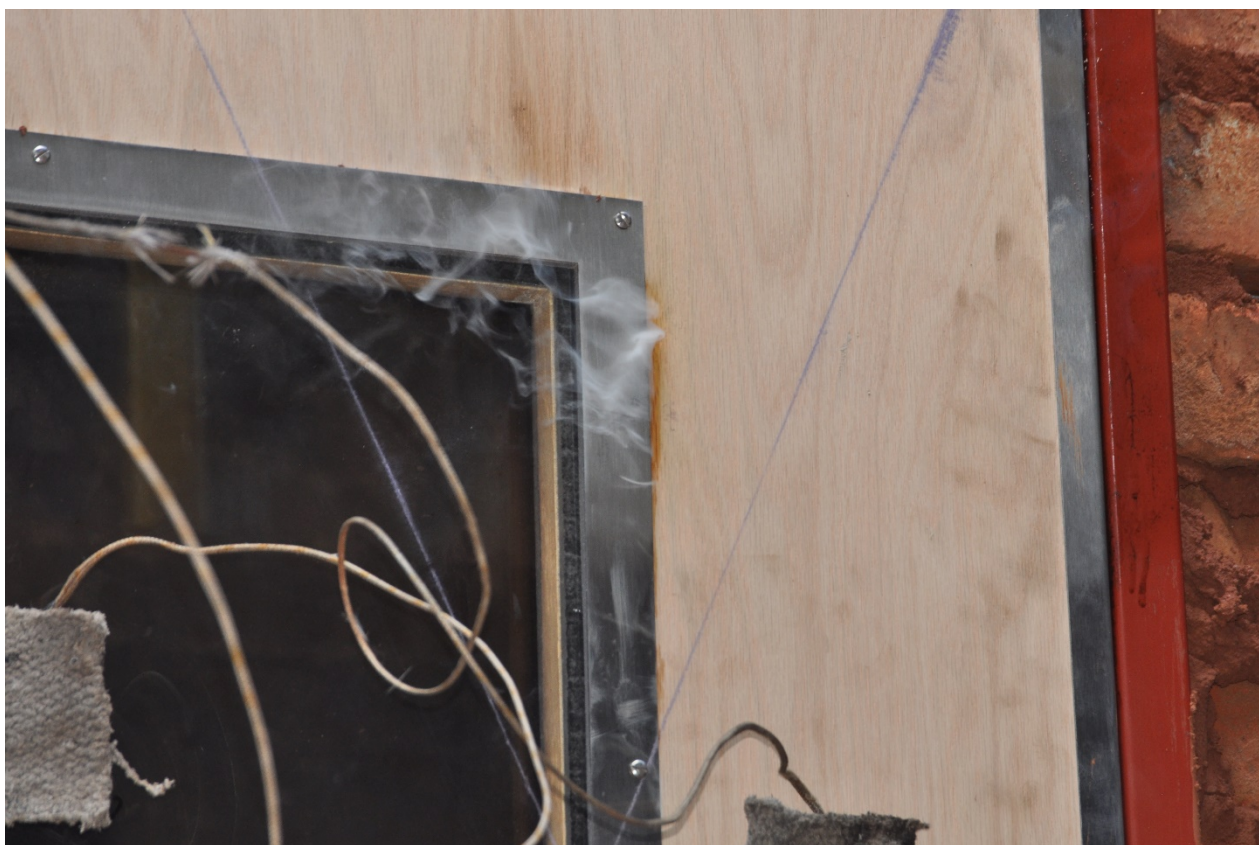
Figure 4.2.8: Discoloration and smoke release on edge of glazing (view panel)

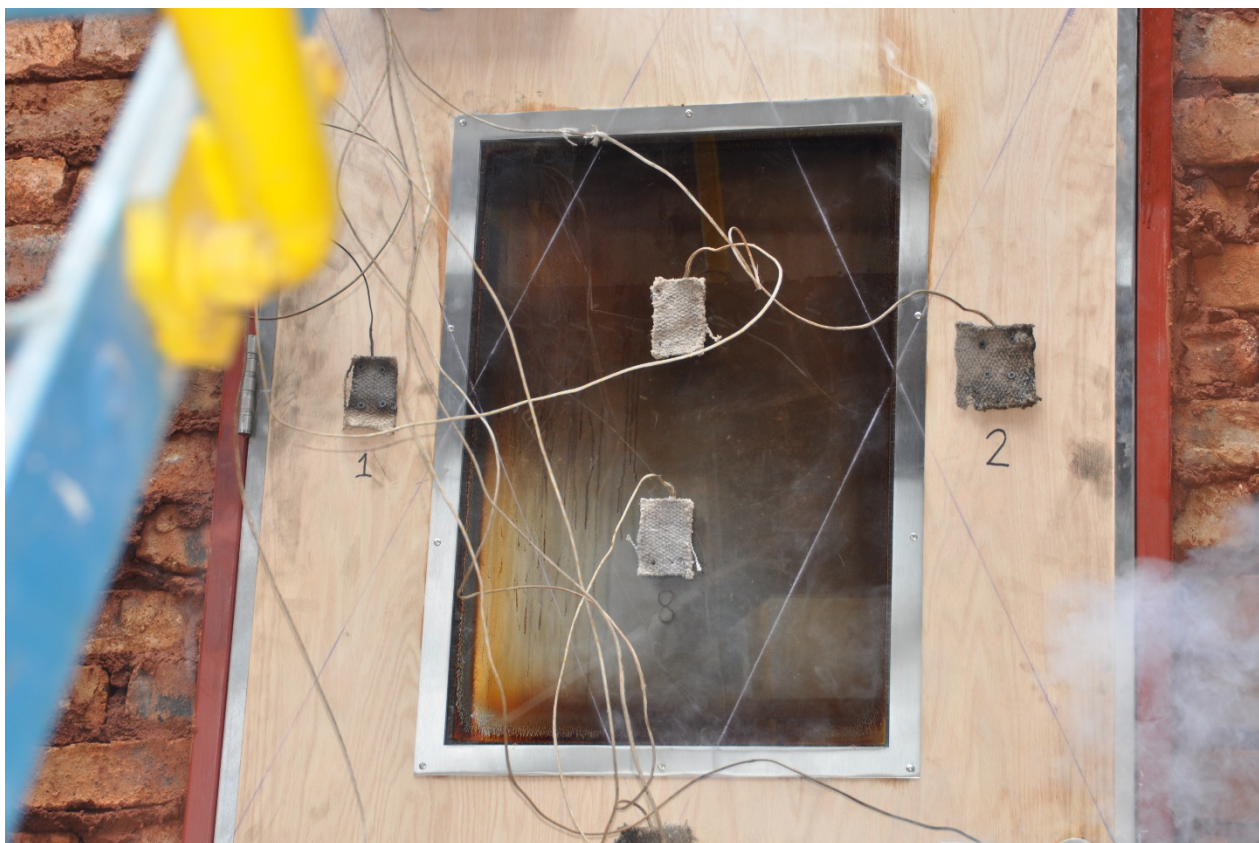
00:14:09	Condensate forming inside glazing (view panel)
00:14:57	Discoloration increases at bottom perimeter
00:18:20	Glass continues to darken
00:19:12	Lockset darkening

Figure 4.2.9: Condensate forming inside glazing (view panel)

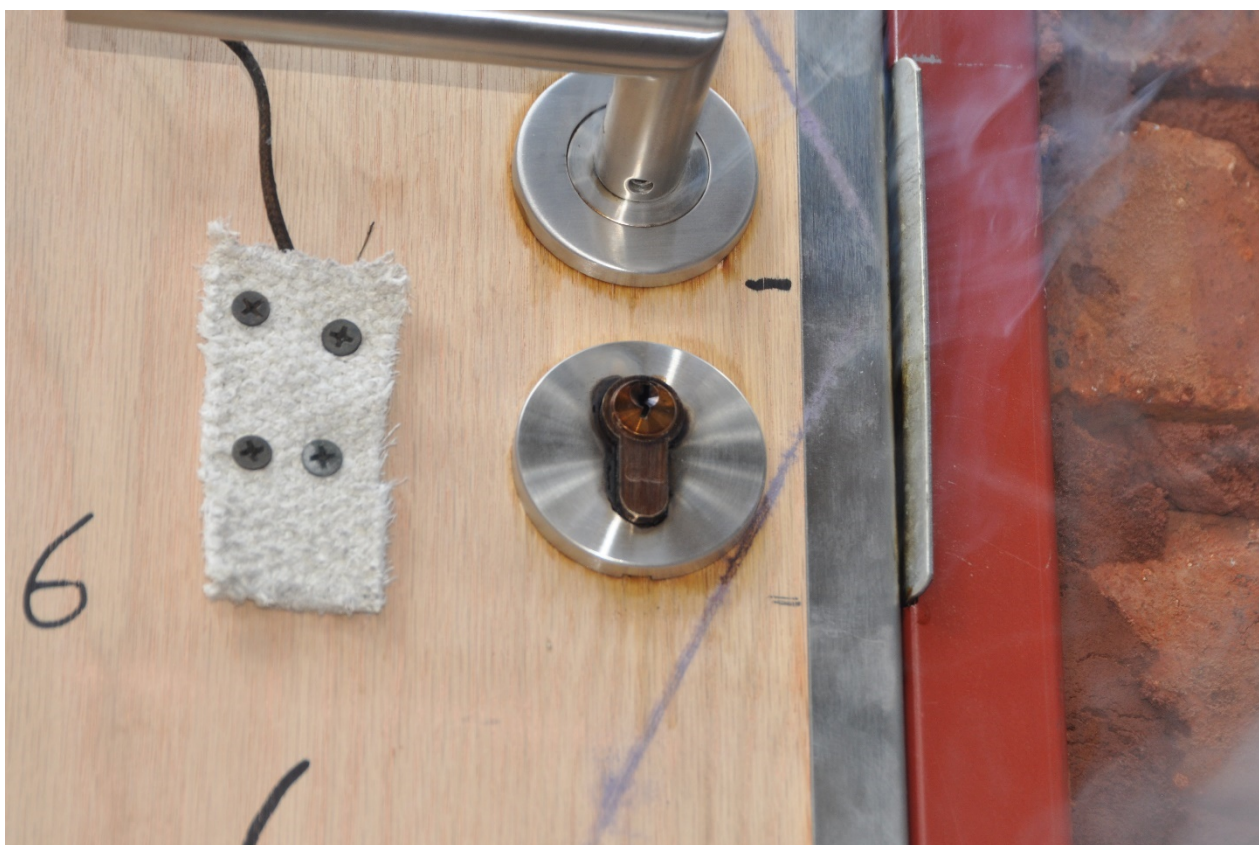
Figure 4.2.10: Lockset darkening

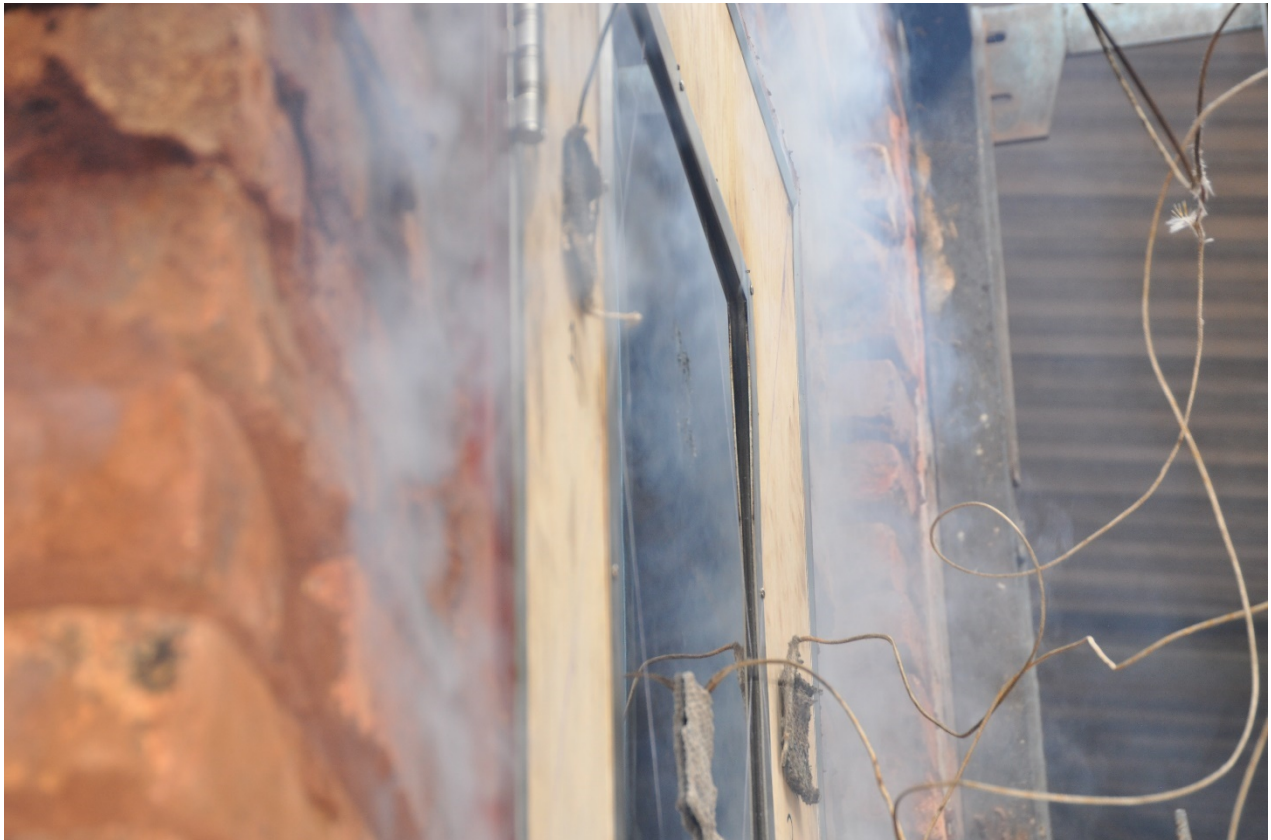
00:38:00	Material between steel frame and glass on unexposed side expanding
00:39:24	Discoloration darkening around lockset
00:40:57	Charring at lockset
00:41:36	Liquid oozing from door closer and crack sound can be heard

Figure 4.2.11: Material between glass and steel frame expanding

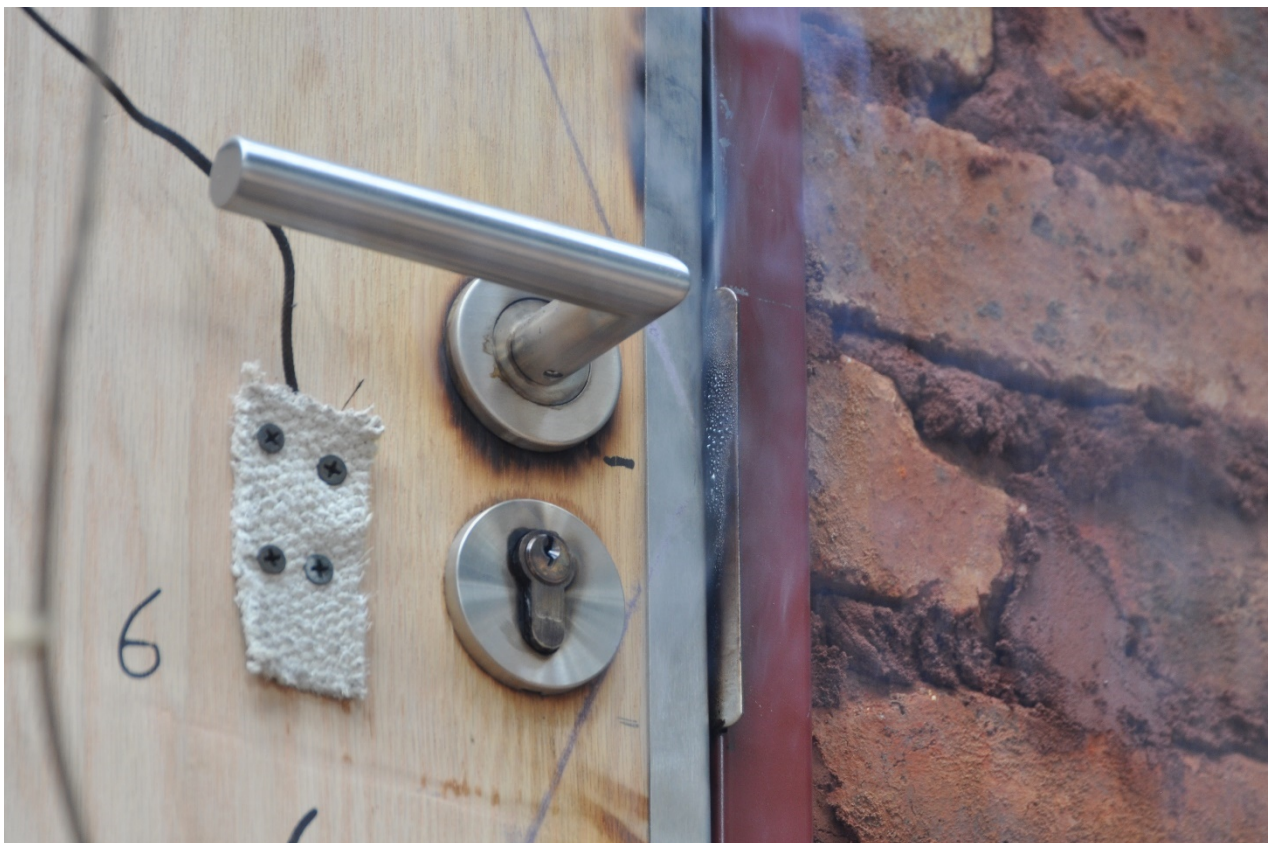
Figure 4.2.12: Charring at lockset

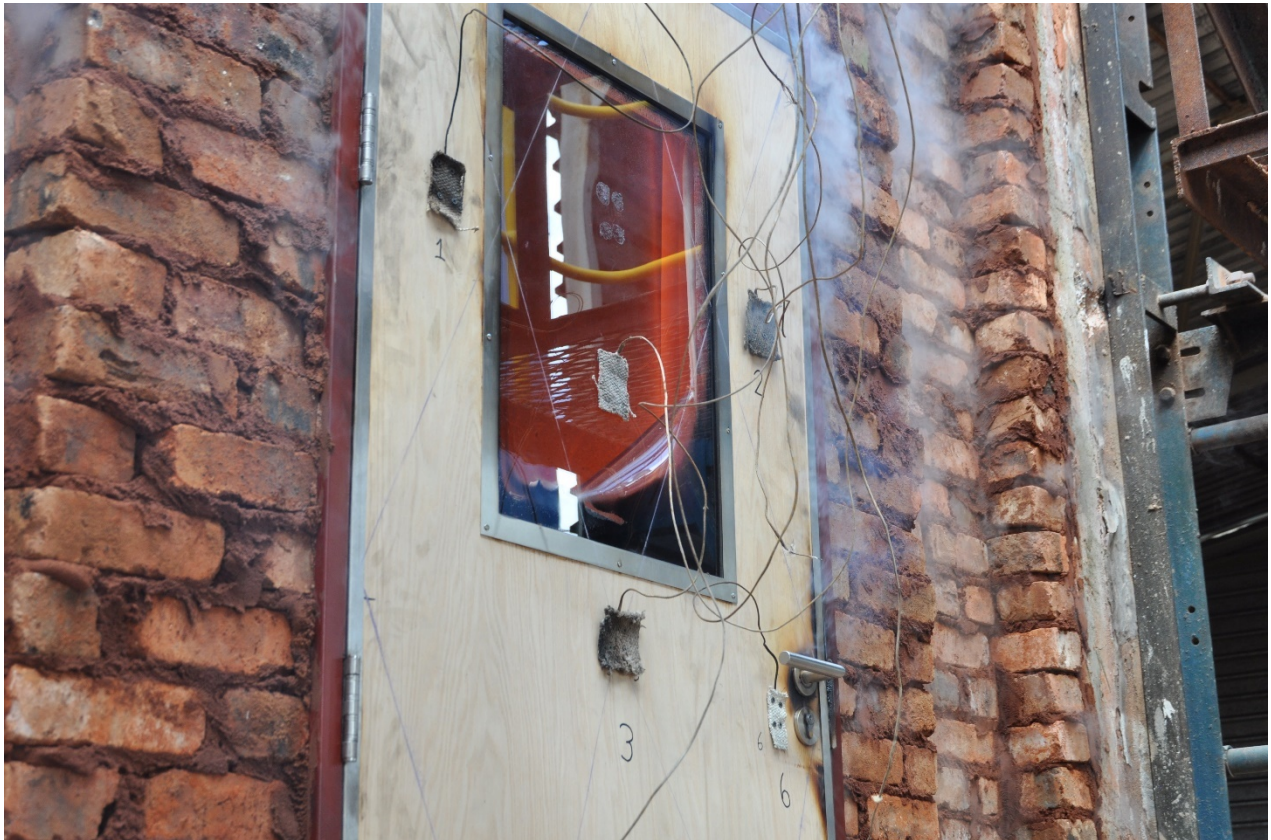
Figure 4.2.13: Glass on exposed side melted

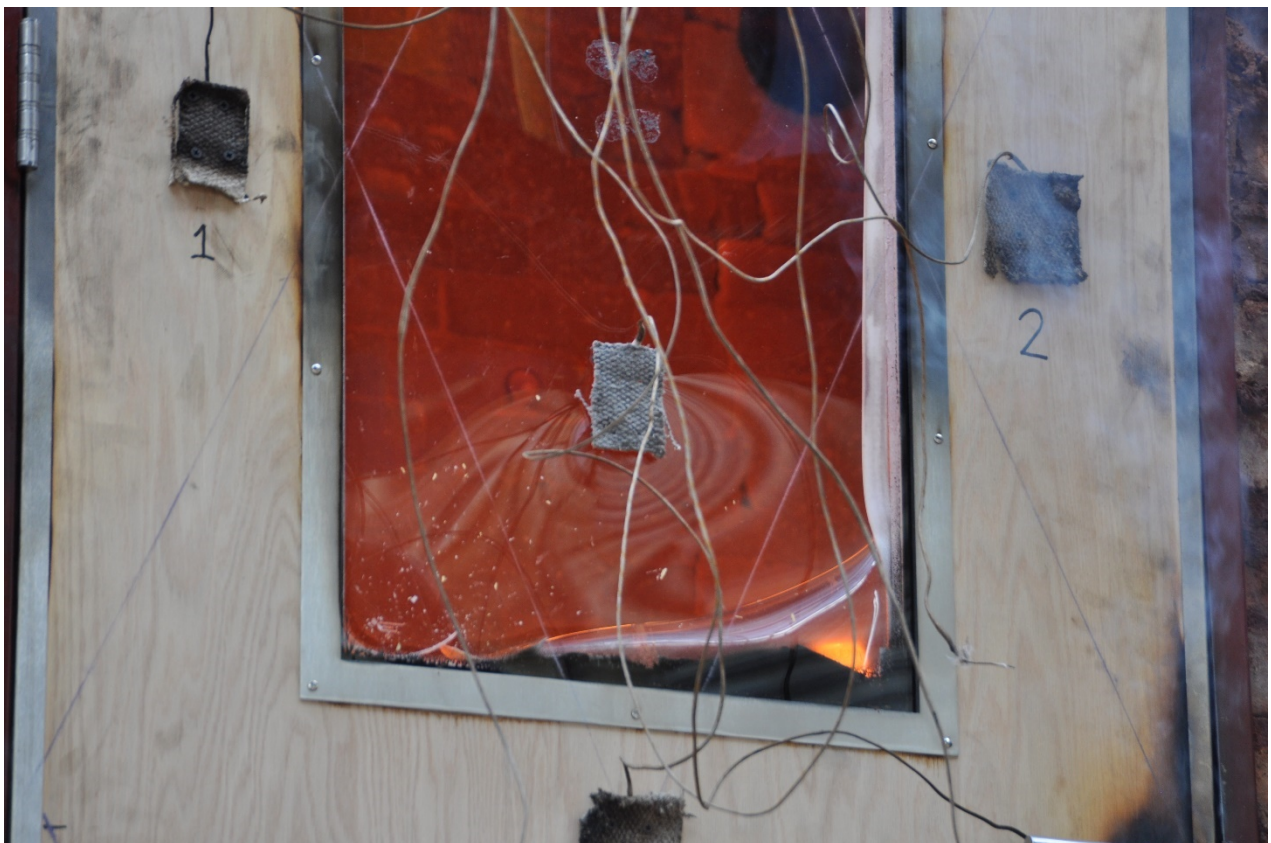
Figure 4.2.14: Glass on unexposed side deforming

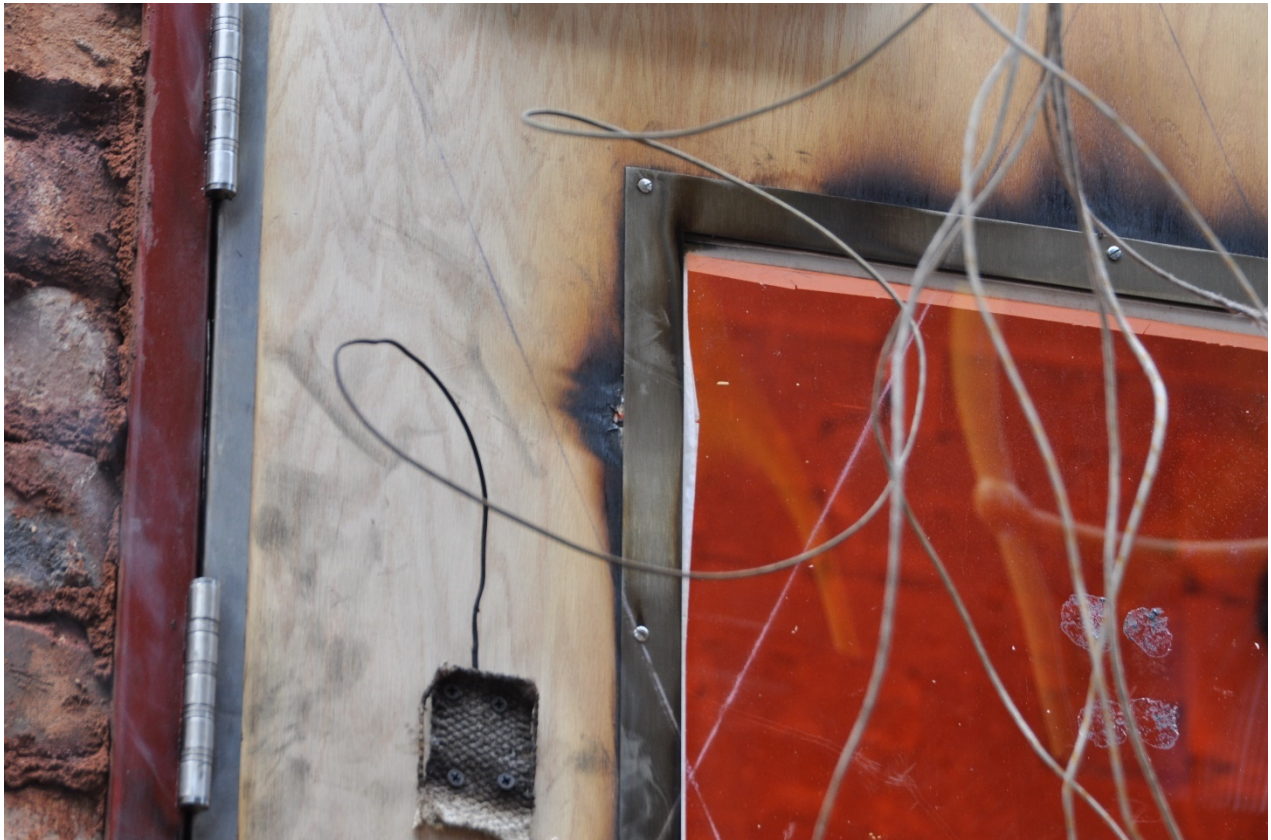
Figure 4.2.15: Glowing on timber, left of glazing (view panel)

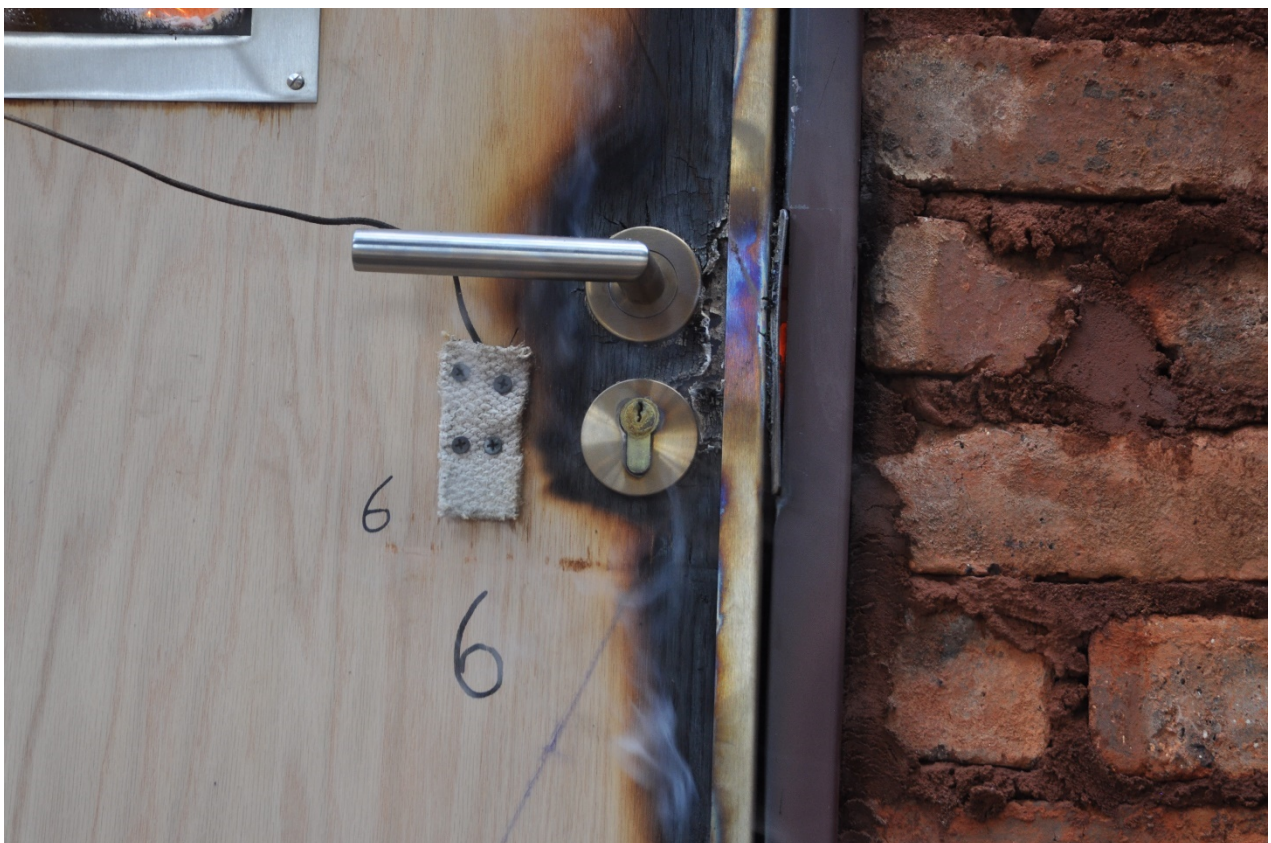
01:12:07	Charring increase around edges
01:13:00	Discoloration on steel near lockset
01:14:05	Steel stripping away from timber on left of glazing (view panel)

Figure 4.2.16: Discoloration on steel near lockset

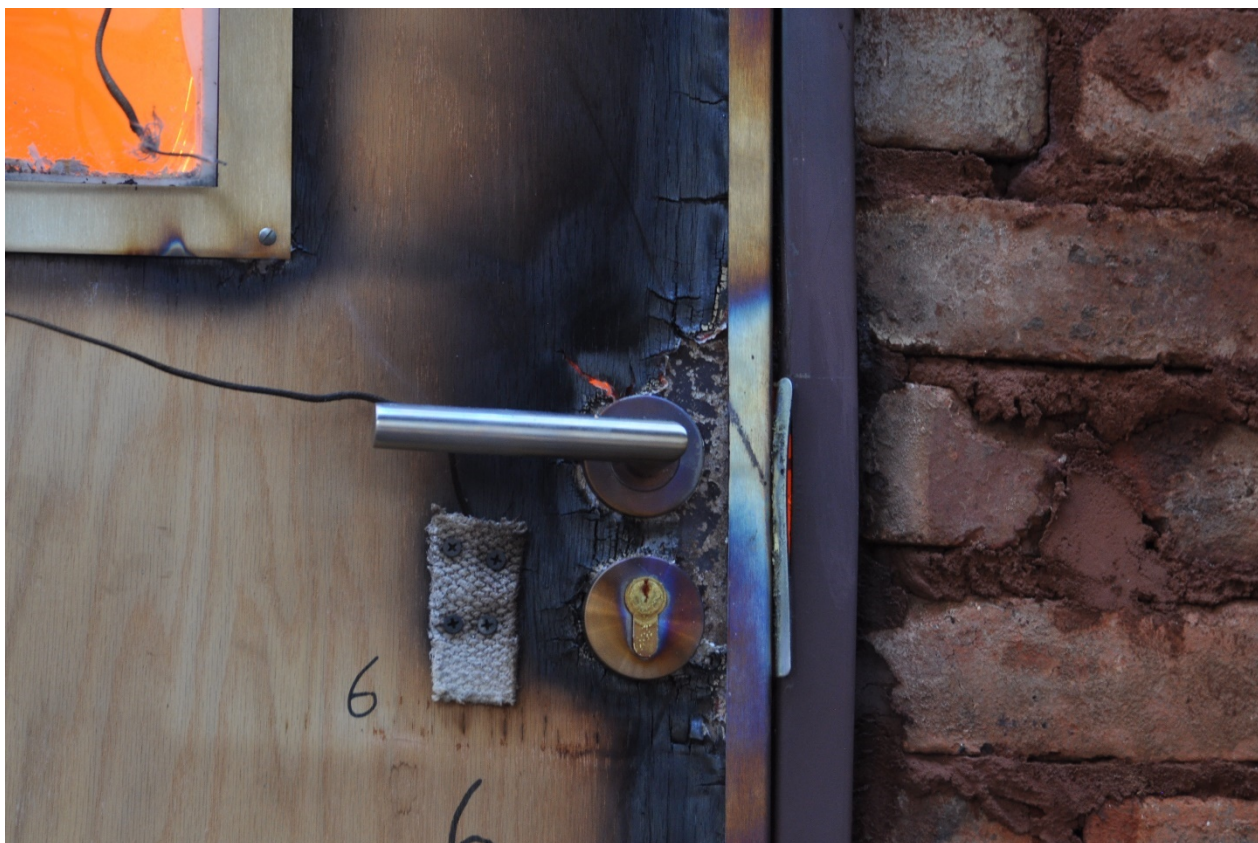
Figure 4.2.17: Lockset turning yellow

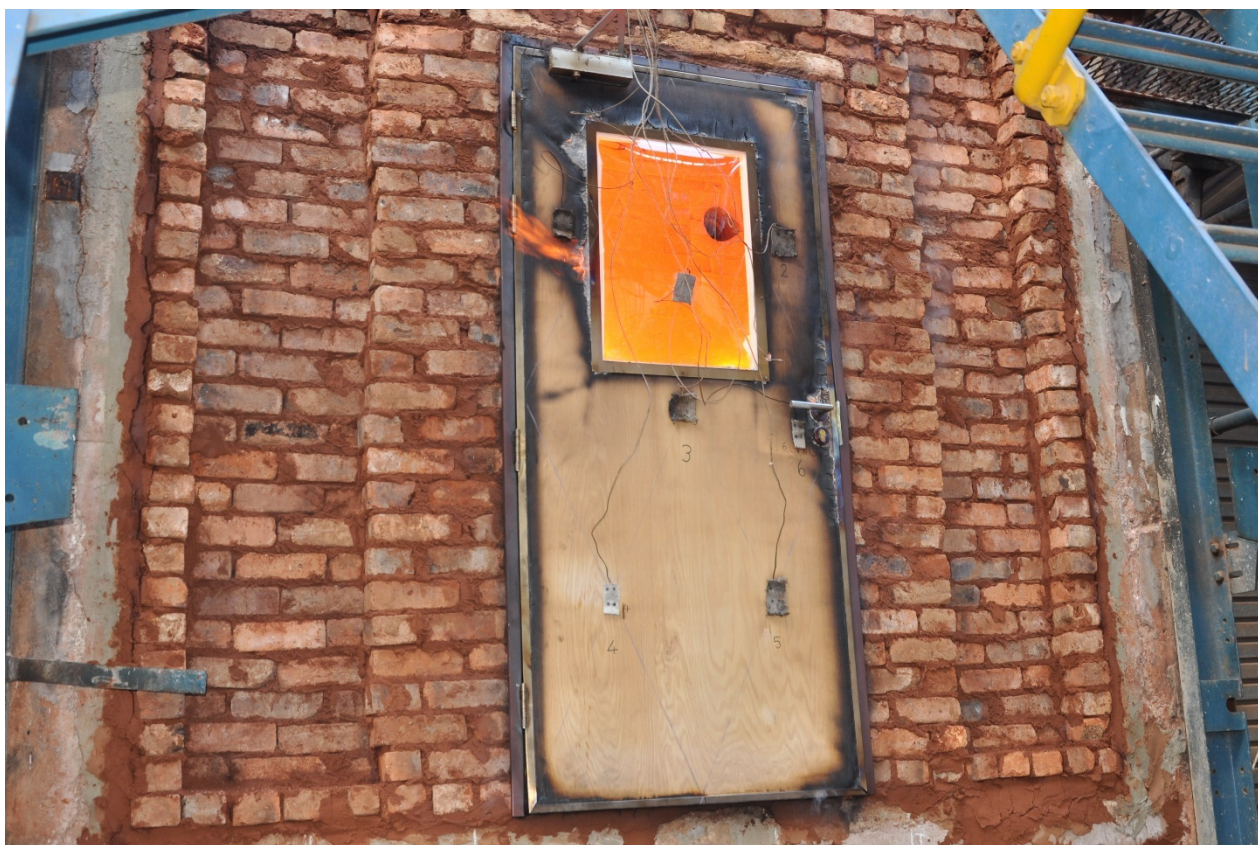
01:47:13	Ignition left of glazing (view panel)
01:47:42	– Test Concluded –

Figure 4.2.18: Ignition left of glazing (view panel)

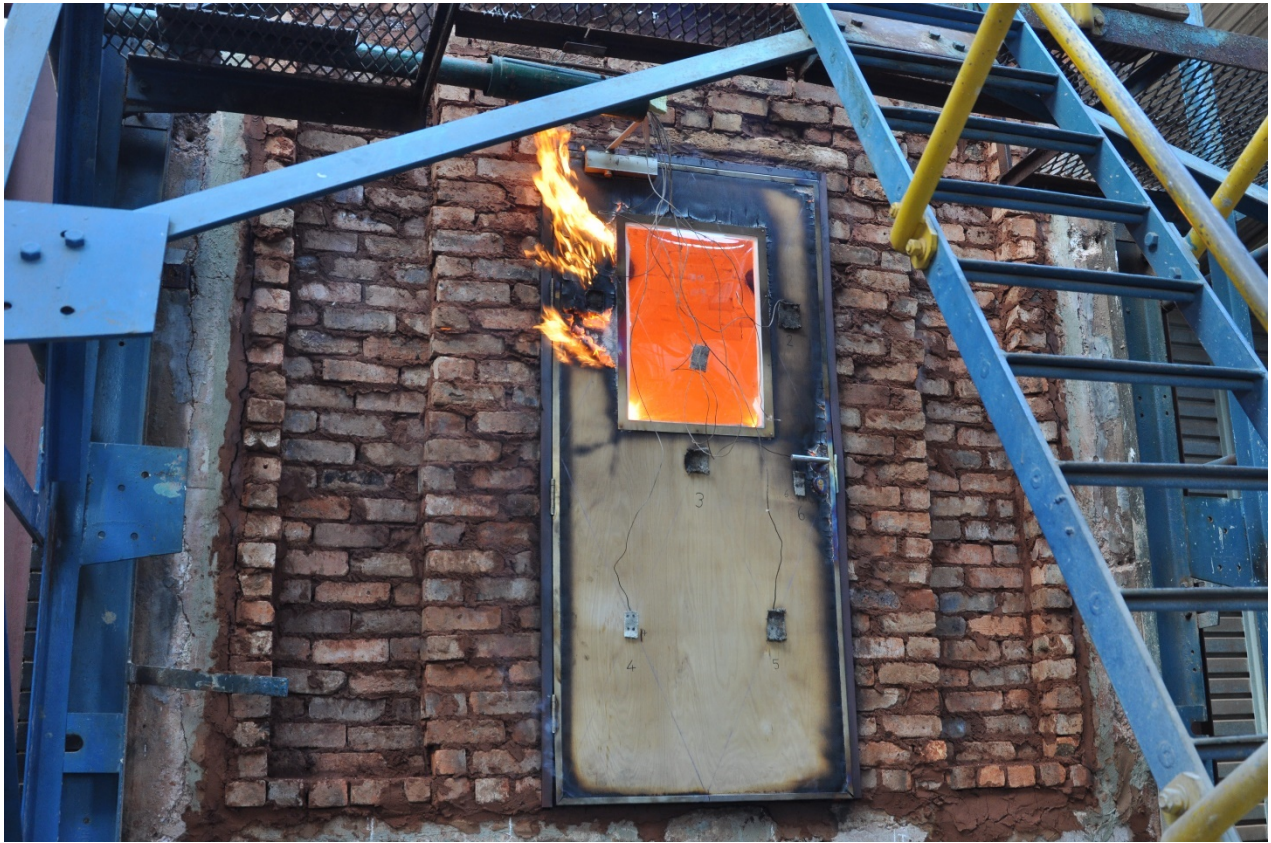
Figure 4.2.19: Flaming rapidly spreading on unexposed side

- 🔥 Stability (R):** The specimen sustained flaming on the unexposed side at approximately 1 hour and 47 minutes. The maximum distance that the door moved out of its frame was 22 mm at 100 minutes at the bottom right corner.

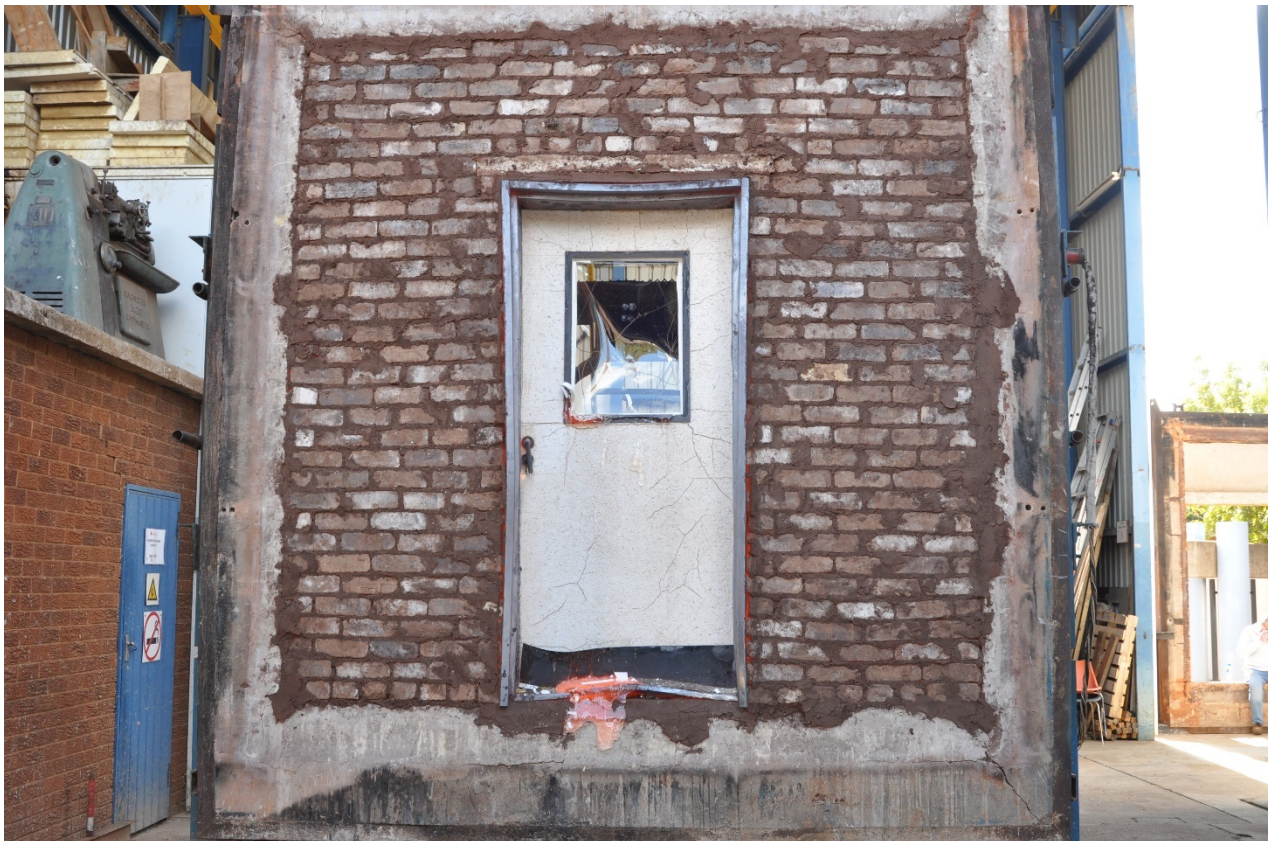
Figure 4.2.20: Exposed side of specimen at conclusion of the **Fire Resistance** test

- 🔥 Integrity (E):** No straight through gaps were observed that exceeded 10 mm in width. There were also no straight through gaps with a width more than 6 mm, not exceeding 10 mm and of combined length which exceeded the greater of the width or the height of the door for a period of 60 minutes. The cracks that were observed on the unexposed side were not wide and long enough to contribute to failure of the test. The flaming on the unexposed side of the specimen was assisted by a large gap that formed on the side of the view panel, which also led to integrity failure.

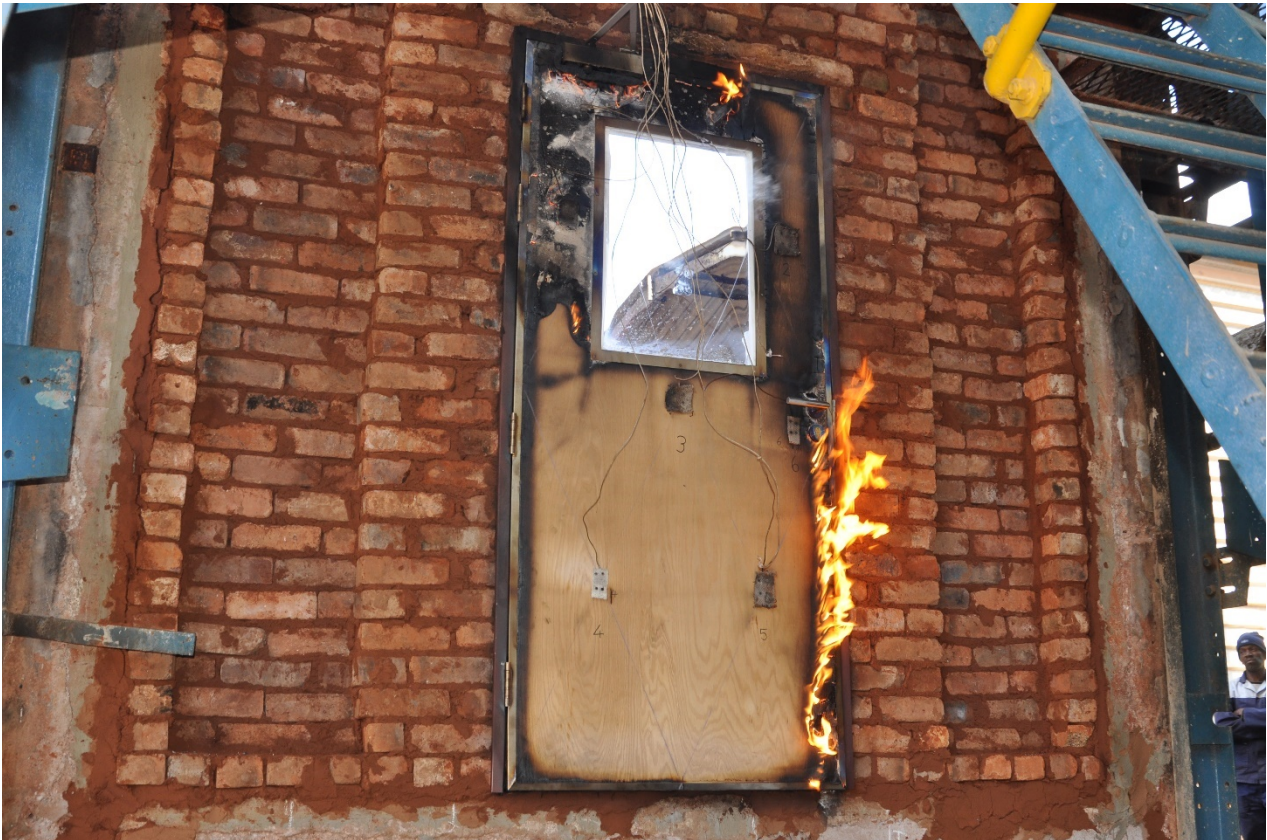
Figure 4.2.21: Unexposed side of specimen at conclusion of the **Fire Resistance** test

- 🔥 Insulation (I):** None of the standard 5 thermocouples, placed on the remaining door leave, registered temperatures above the allowed maximum of 195.6 °C before 60 minutes. TC 1 and 2, however, raised above this maximum just after 100 minutes and the average above its allowed maximum of 155.6 °C between 100 and 110 minutes. The temperatures measured on the view panel went above 195.6 °C at approximately 13 minutes of the test.
