TEST REPORT

Your ref: 46917
Our ref: FPE/61334/20
Enquiries: J Maswikaneng
Tel: (012) 428-6010
Report No: BCT-201210-00023
Page: 1 of 8
Date: 2020/12/15

FIRE TESTING OF MATERIALS, COMPONENTS AND ELEMENTS USED IN BUILDINGS SANS 10177 Part 2: 2005 "FIRE RESISTANCE TEST FOR BUILDING ELEMENTS"

Test specimen consisted of a 2170 mm high by 2270 mm wide non-load bearing, steel framed glazed screen with a double door. The system was similar in appearance to a shop front.

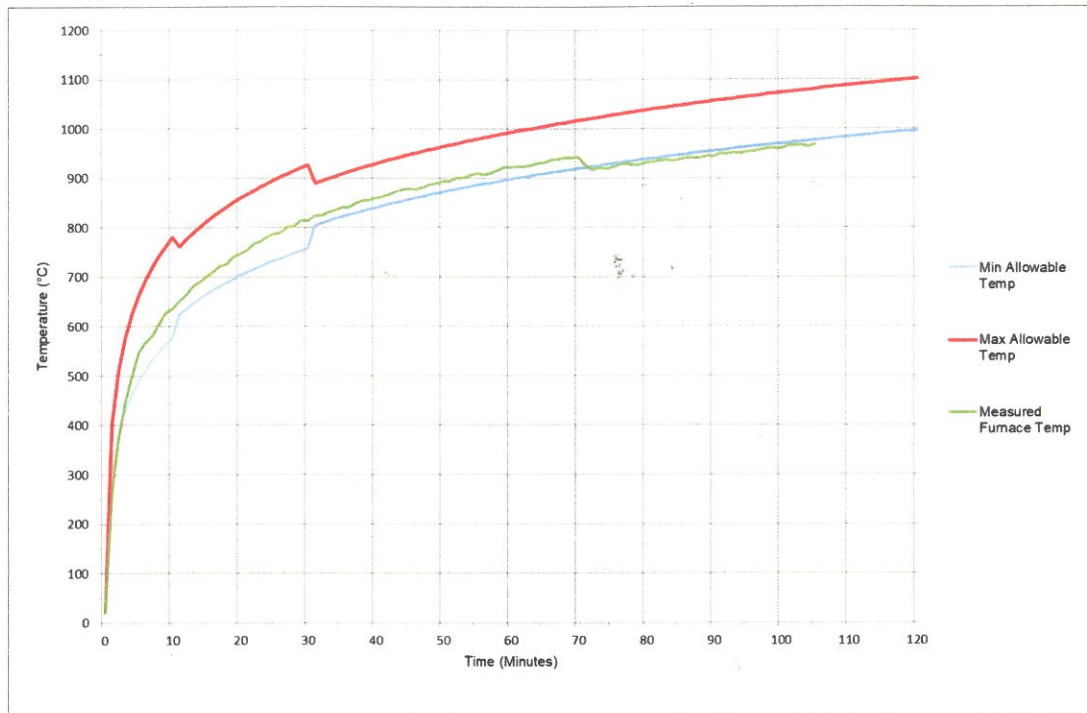
Figure 1: Furnace temperatures recorded during the test:

NOTE 1: During the 71st minute into the test there occurred an anomaly that resulted in the furnace temperature dipping and staying below the allowable minimum furnace temperature (See furnace time-temperature curve on next page). This was unplanned and out of the control of the test officers performing the test. We believe it was caused by dirty diesel fuel blocking some of the furnace burners resulting in the burners extinguishing during the test. **At 105 minutes the electrical grid that the furnace worked of tripped due to an earth leakage breaker tripping. This effectively stopped the test.** Due to the above unforeseen occurrence the testing authority is only able to access and report on the stability and integrity requirements up to 70 minutes into the test. All data and observations in this report that occurred after 70 minutes into the test are only for informative purposes as the furnace temperature was outside the allowable temperature range as specified in the test method.

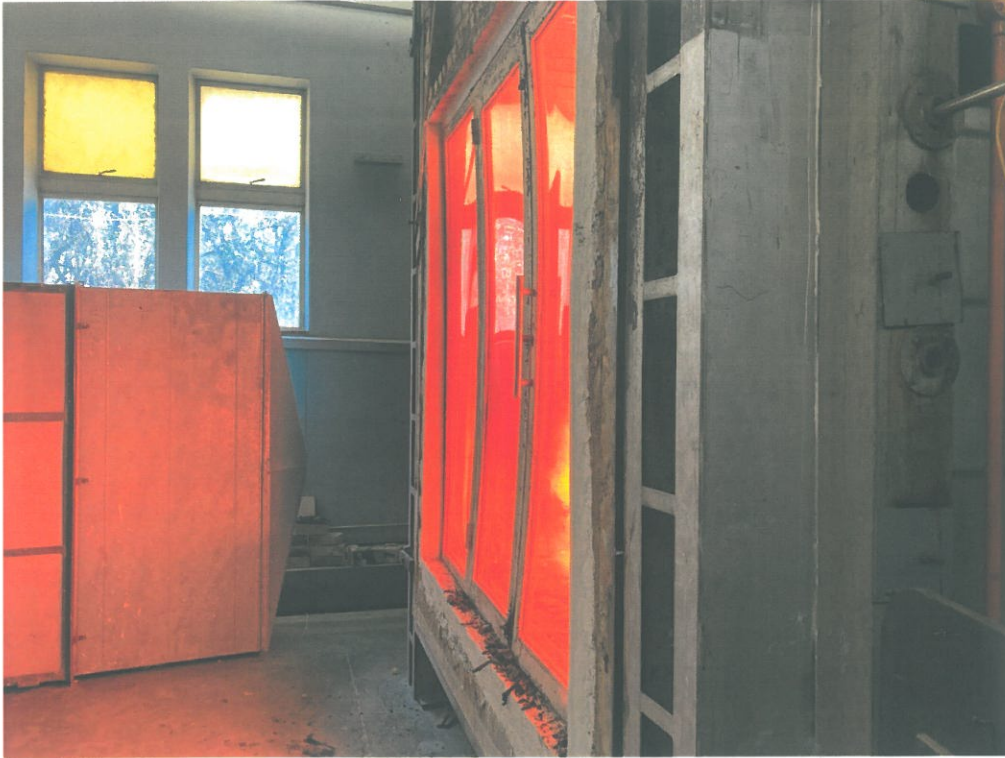
Photo 7: Photo taken of the unexposed side of the system at 70 minutes. Note glass softening but still intact. Also note deflection of framing material.

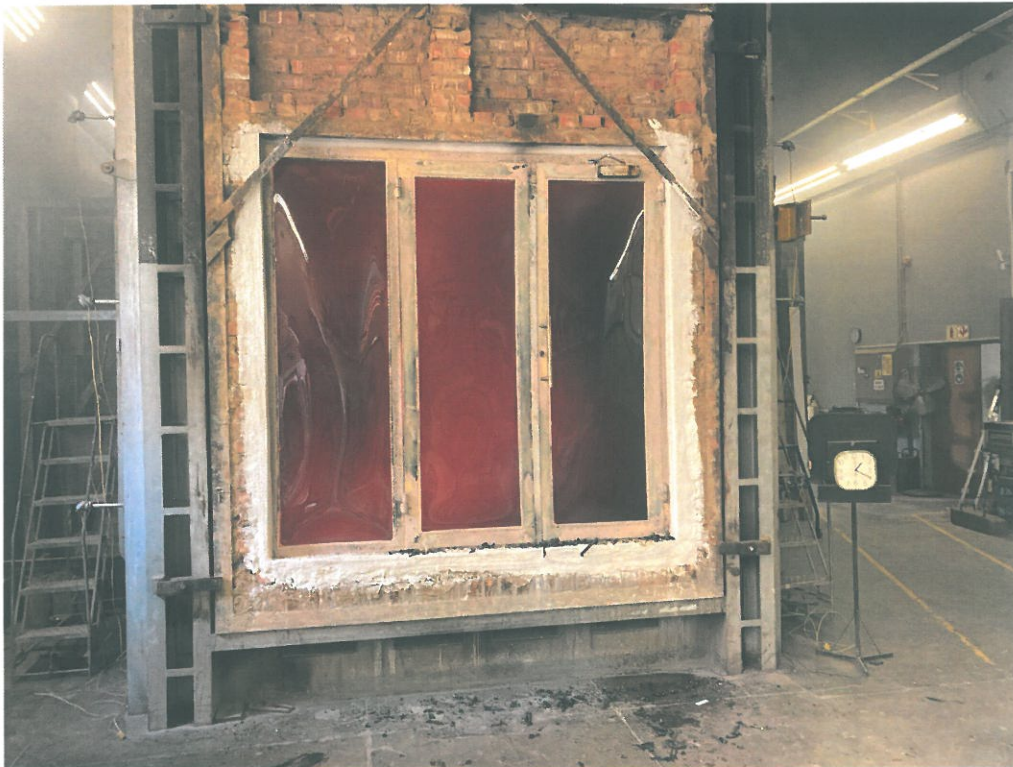
Photo 8: Photo taken of the unexposed side of the system at 80 minutes. Note smoke (unburnt diesel fumes) visible inside furnace due to anomaly at 71 minutes.

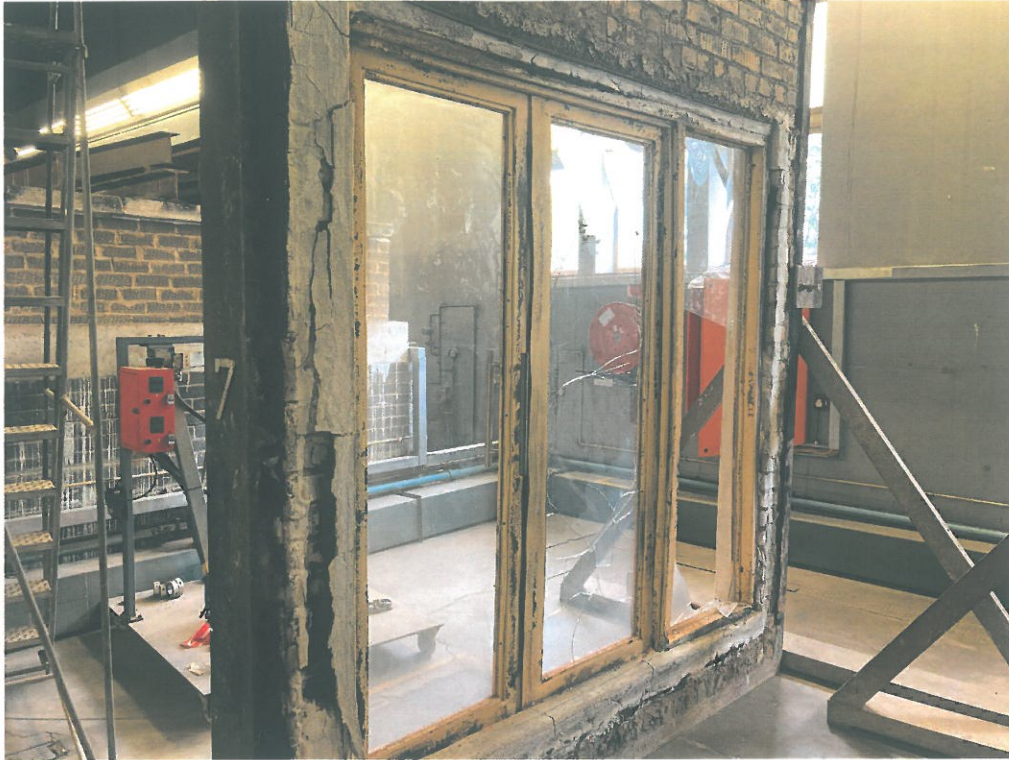
Photo 9: Photo taken of the exposed side of system after termination of test and removal from the furnace. The cracks and holes visible on the glazing only formed after test termination when the class cooled down.
