TITLE	:	Report on the evaluation of the P&H Rocklite Class D Double Fire Door assembly when classified in accordance with SANS 1253
REQUESTED BY	:	P&H Protective Plaster Systems (Pty) Ltd PO Box 11845 ASTON MANOR 1630
CONTRACT No	:	FTS 23/409
ISSUE No	:	1
DATE	:	17 November 2023

This report contains the evaluation of the **P&H Rocklite Class D Double Fire Door** when classified in accordance with **SANS 1253: Fire-doors and fire-shutters**.

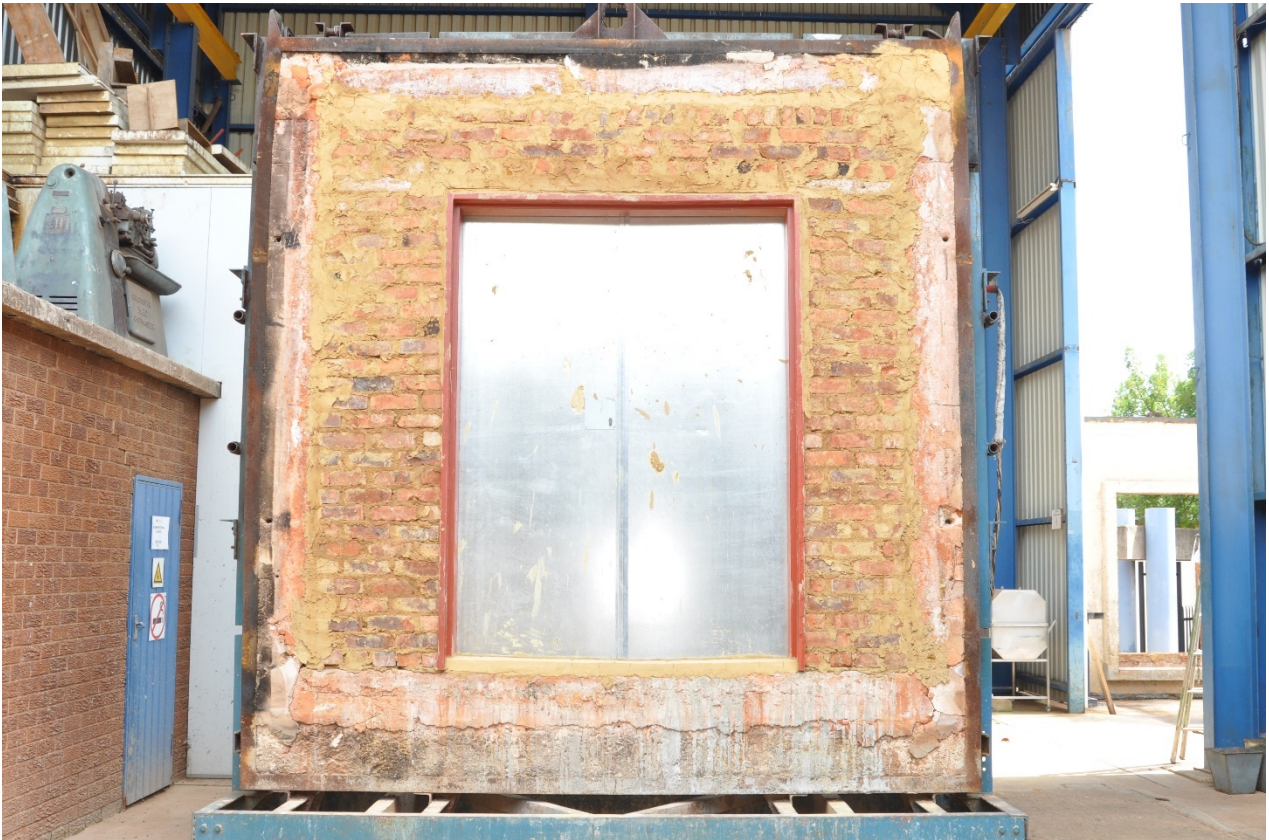
Figure 2.1: The **Rocklite Class D Double** from the exposed side prior to the test

The exposed and unexposed sides of the door specimen prior to the test are shown in Figures 2.1 and 2.2.

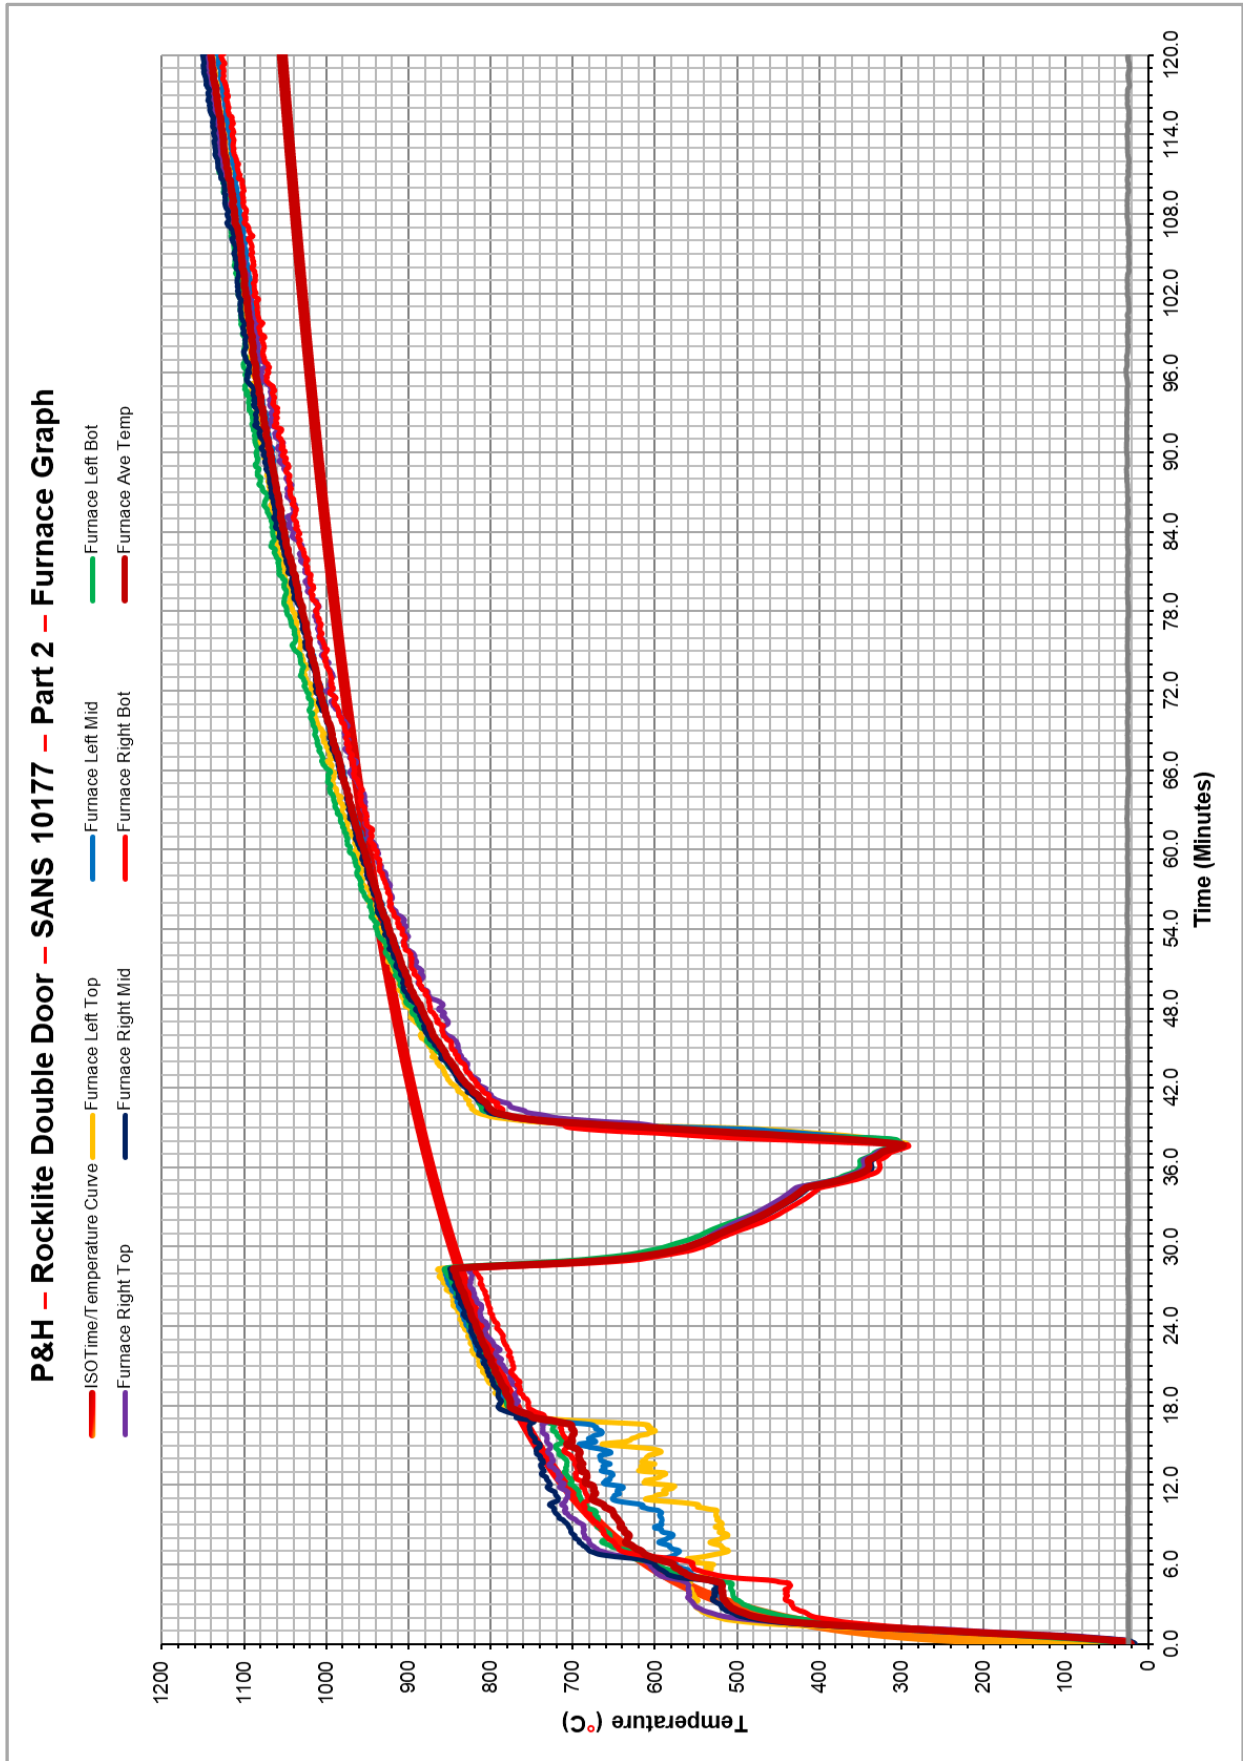
Figure 4.2.1: Furnace temperatures recorded during the large-scale FR test

The furnace temperature was controlled to follow the **ISO standard time-temperature curve** as stipulated in **SANS 10177 – 2**. Six thermocouples (TC) are used to measure the furnace's temperature (three on each side).

Note(s): Tested on 16/11/2023, ambient temperature during the test = 24.7 °C.
Due to technical difficulties the furnace cut out at 28:34 and was restarted by 37:30.
Test duration was extended by 10 minutes to compensate.

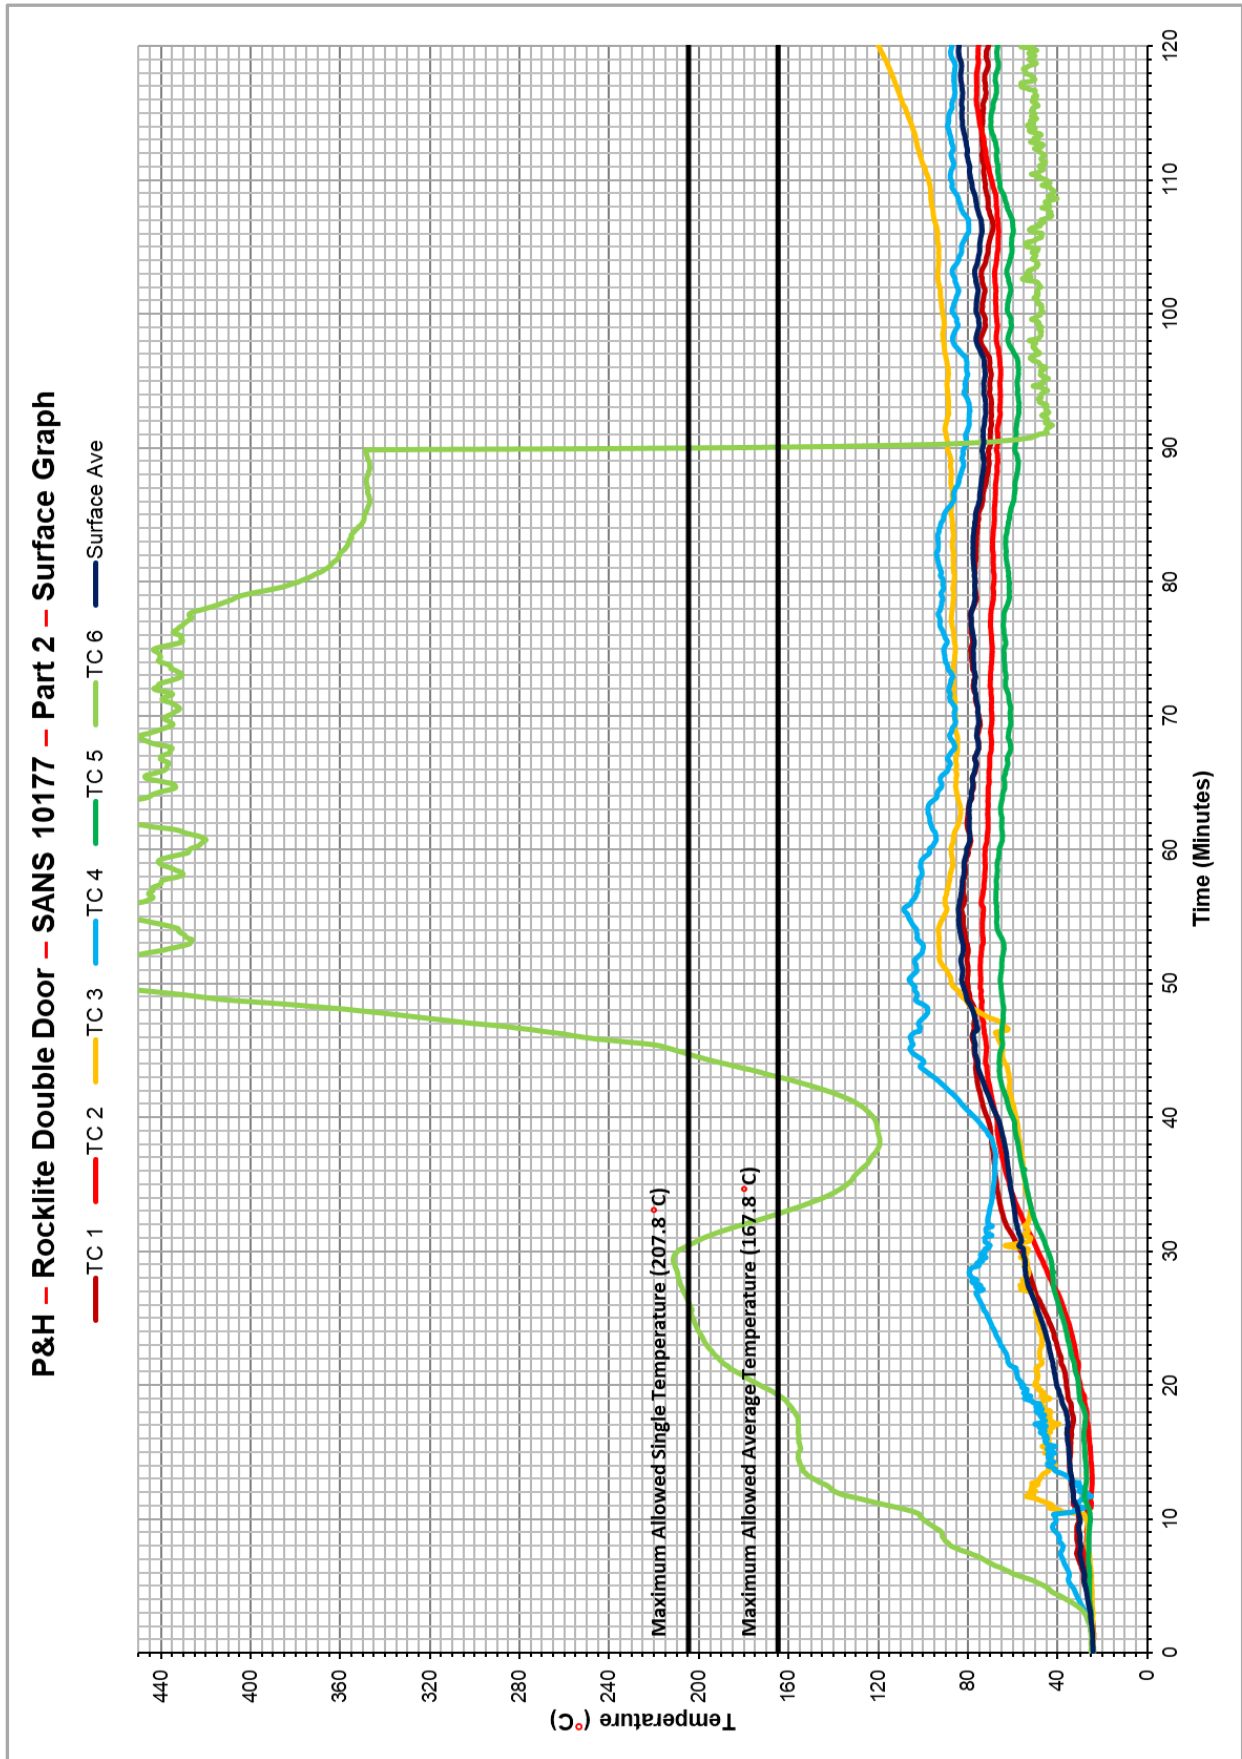
Figure 4.2.2: Temperatures recorded on the surface of the specimen

- **Insulation (I):** All relevant temperatures remained within the allowed maximum for the duration of the test. TC6 exceeded the maximum allowed temperature for a single reading at approximately 26 minutes. However, since TC6 was installed on the interface joint between the two leaves of the double door it is not representative of the larger leaf surface areas. TC6's results will therefore be neglected for insulation criteria purposes.

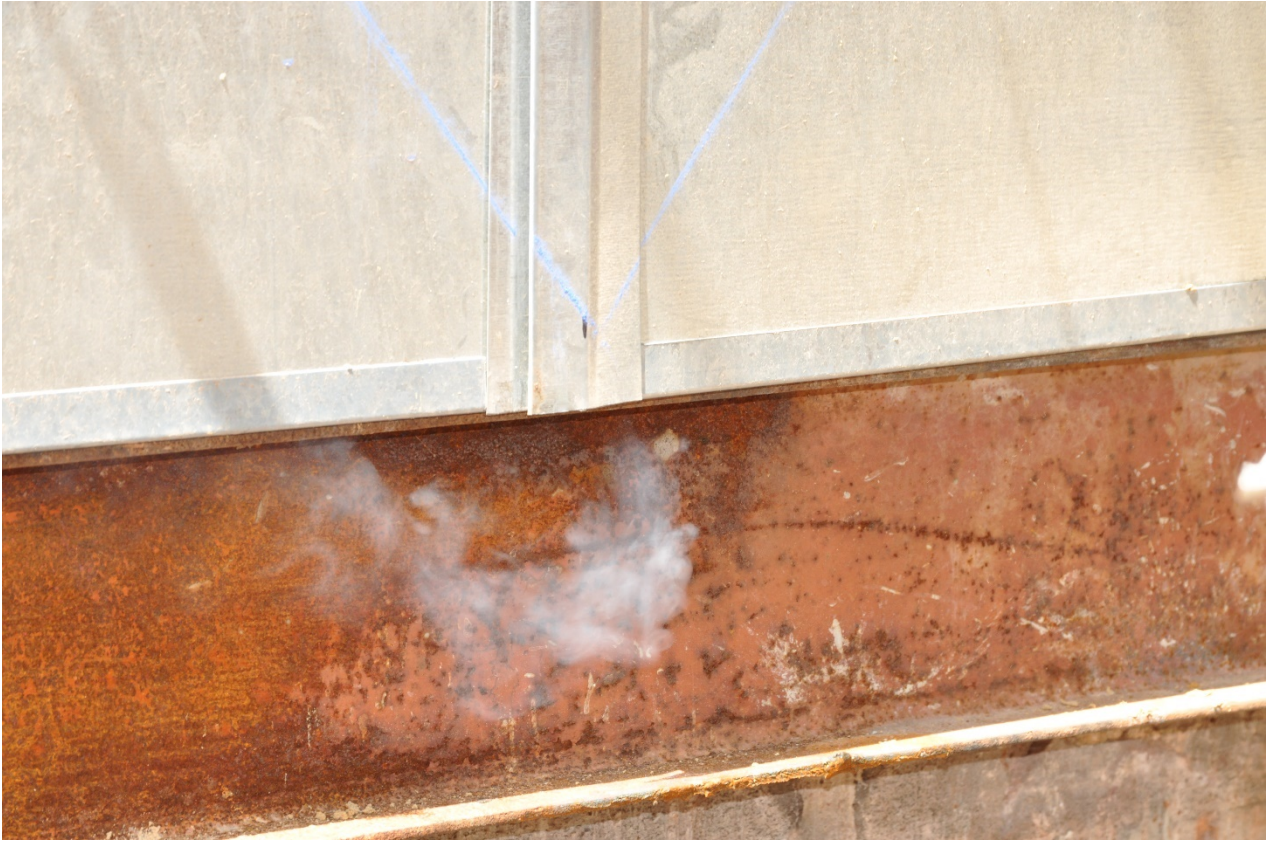
Figure 4.2.3: Slight steam release

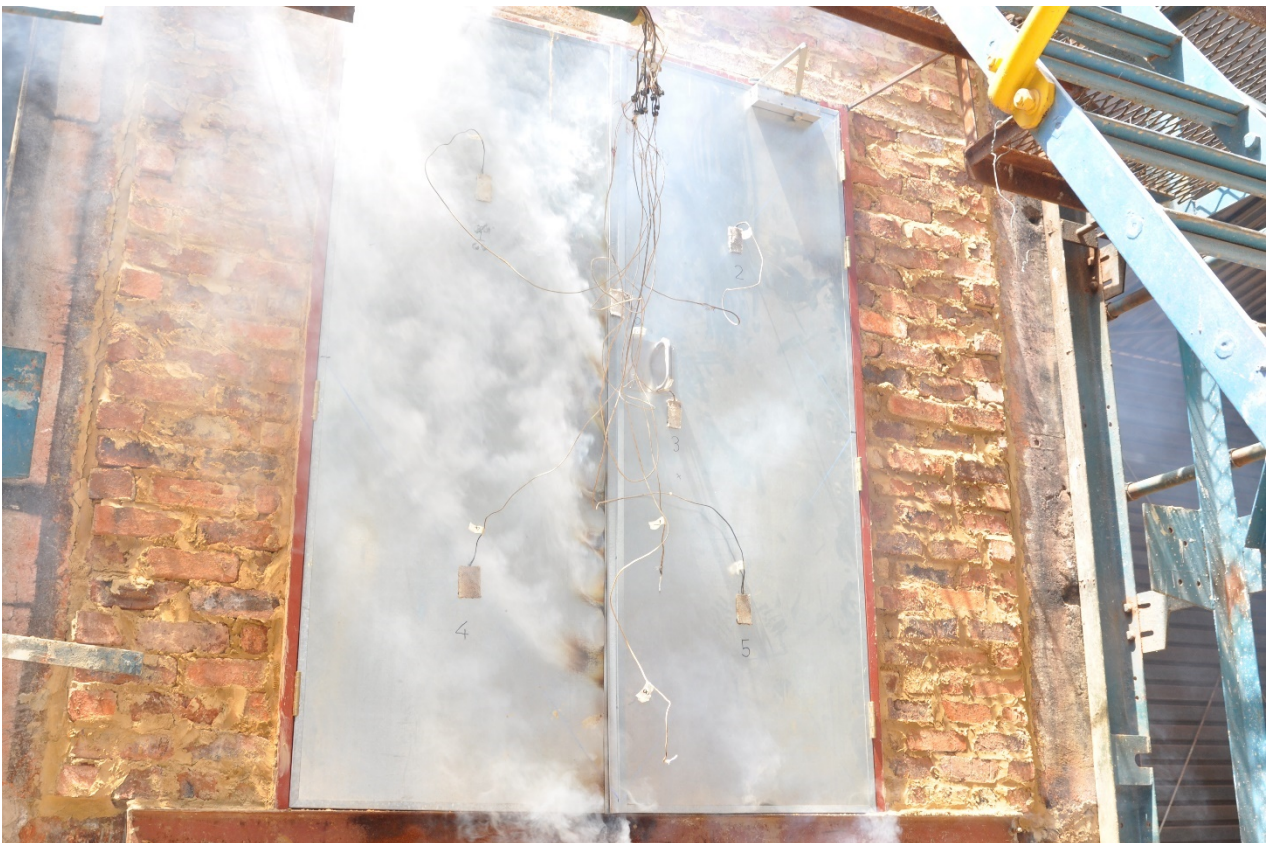
Figure 4.2.4: Smoke release increase

The specimen released smoke during the test, but the smoke did not cause any discomfort in the vicinity area.

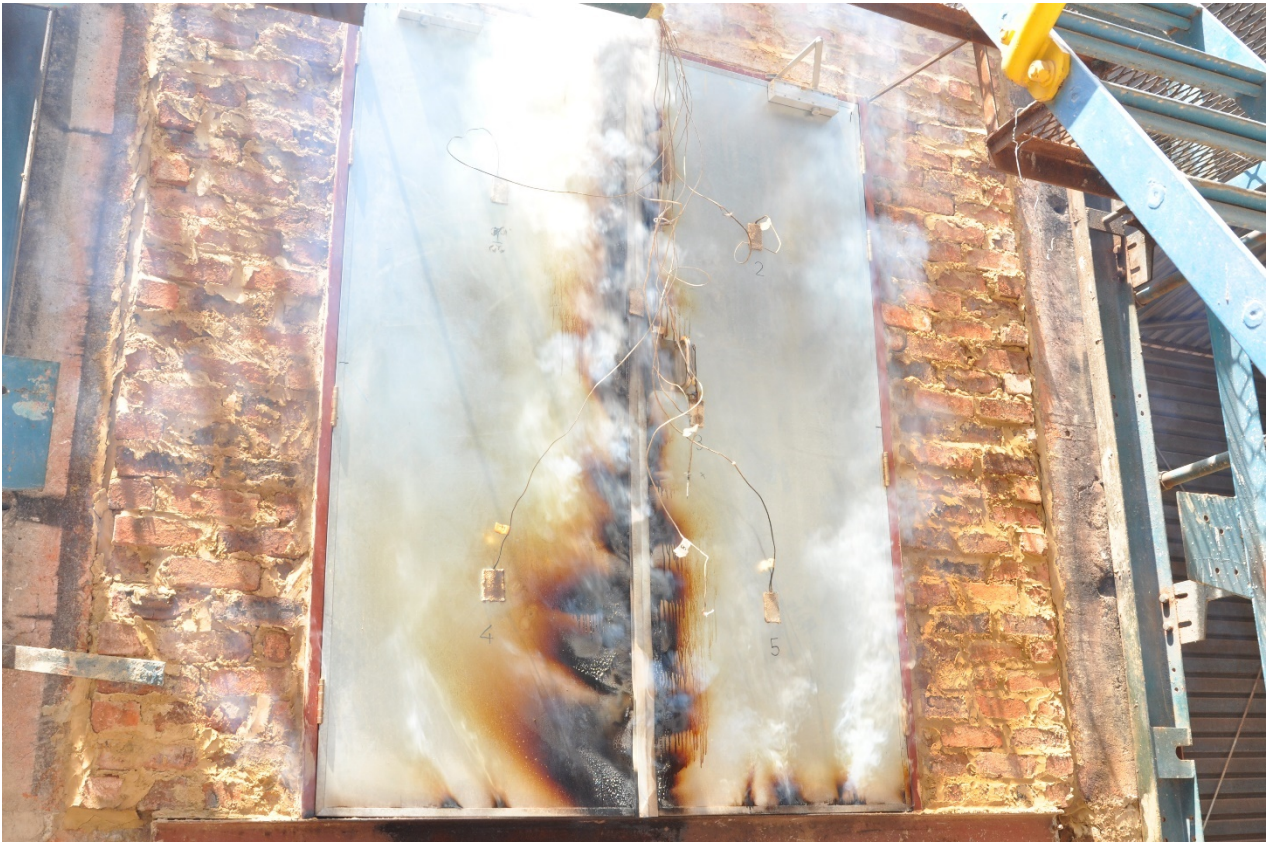
Figure 4.2.5: Discolouration on the door interface

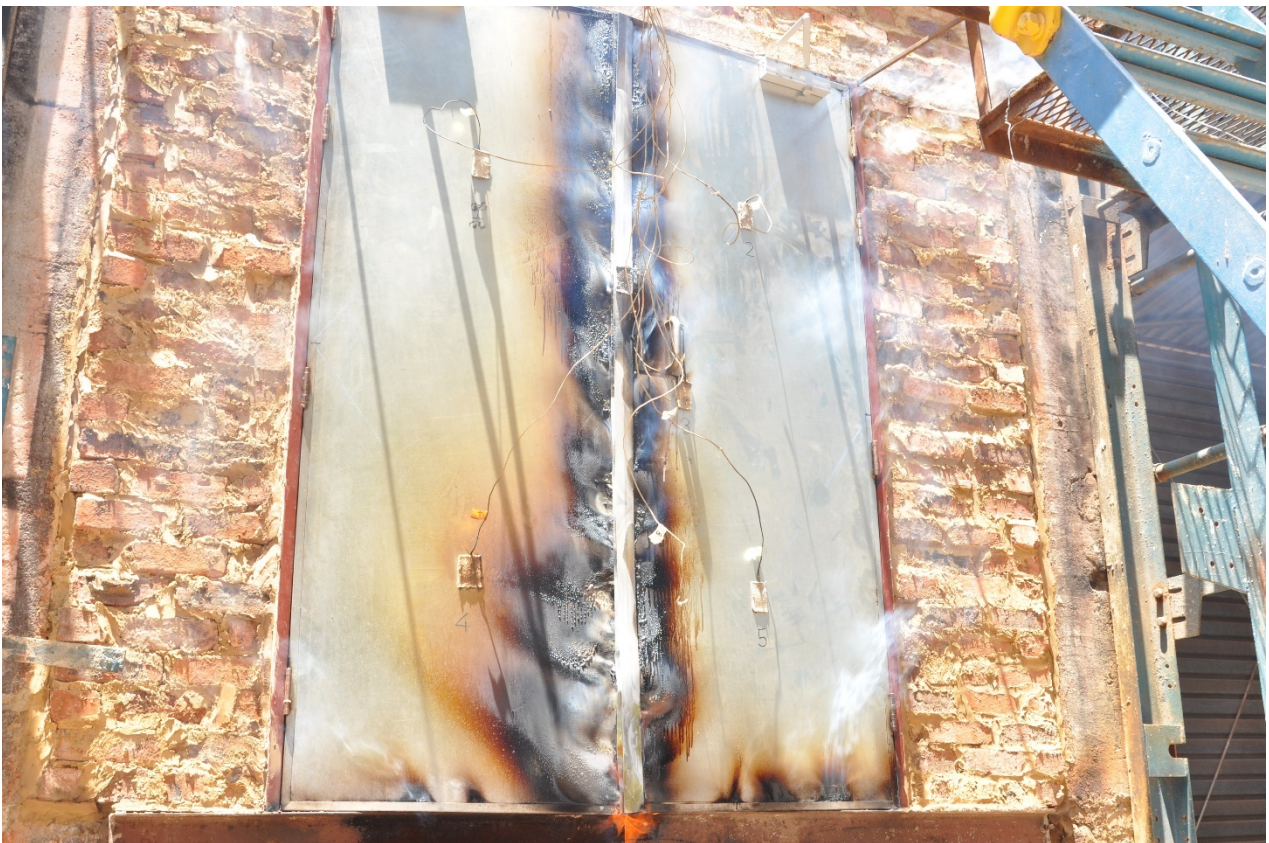
Figure 4.2.6: Door facing warping

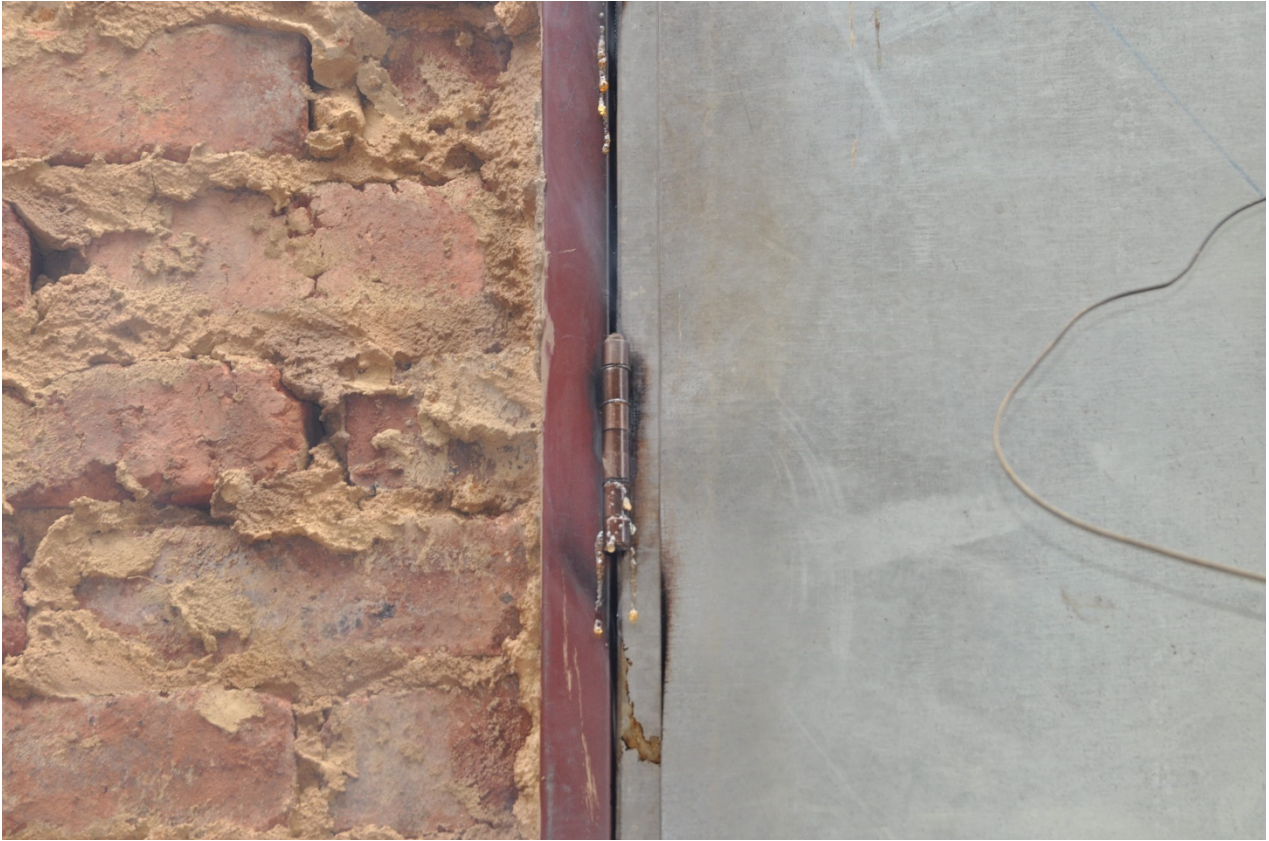
Figure 4.2.7: Hinge washers melting

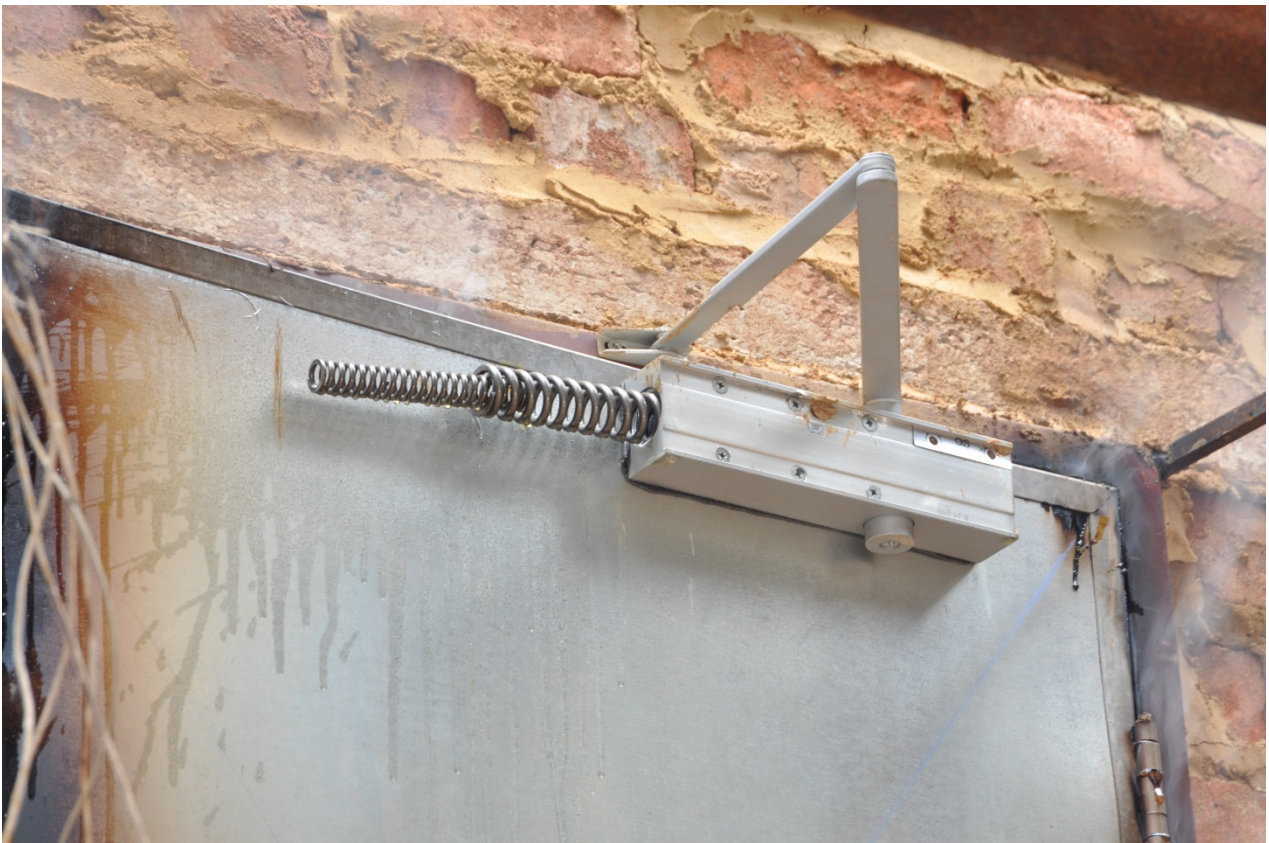
Figure 4.2.8: Door closer rupture

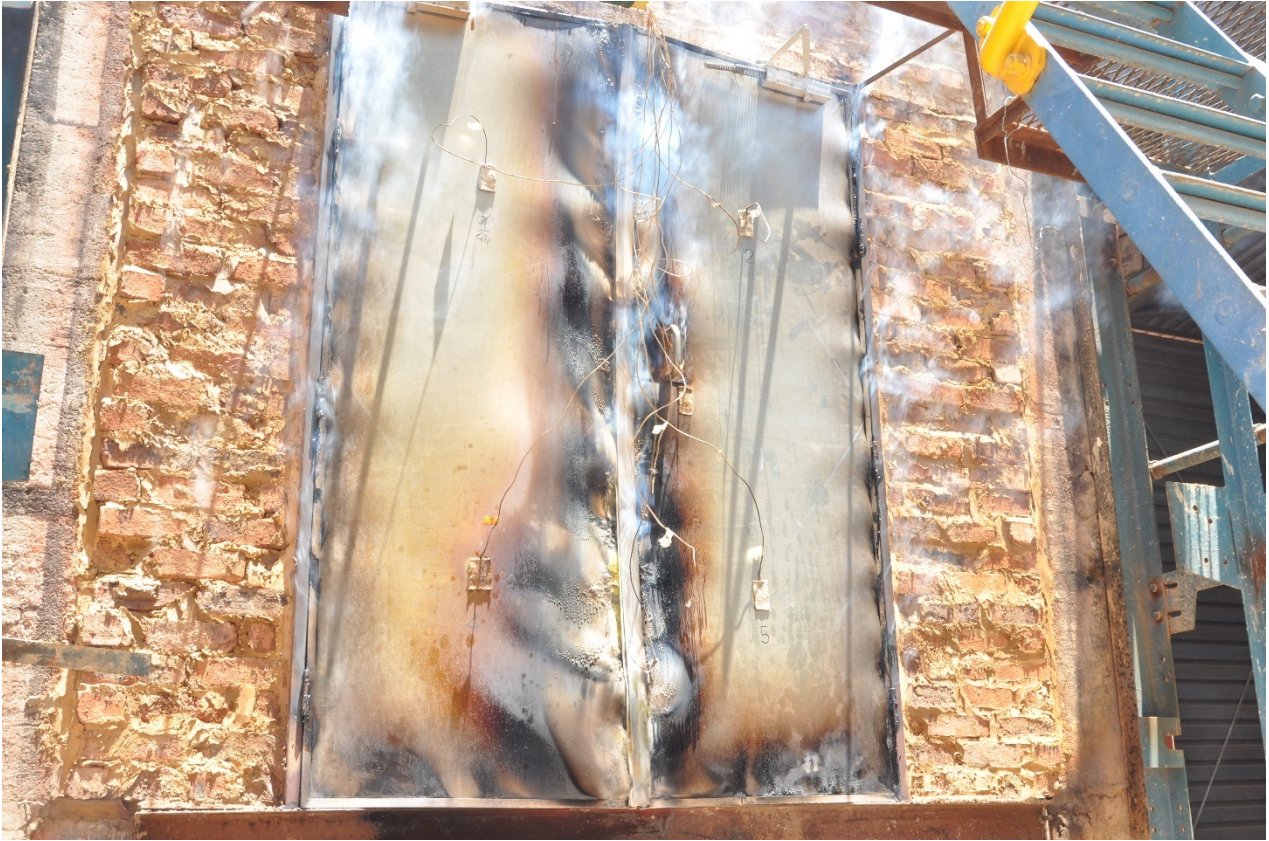
Figure 4.2.9: Door facing warping at 2 hours

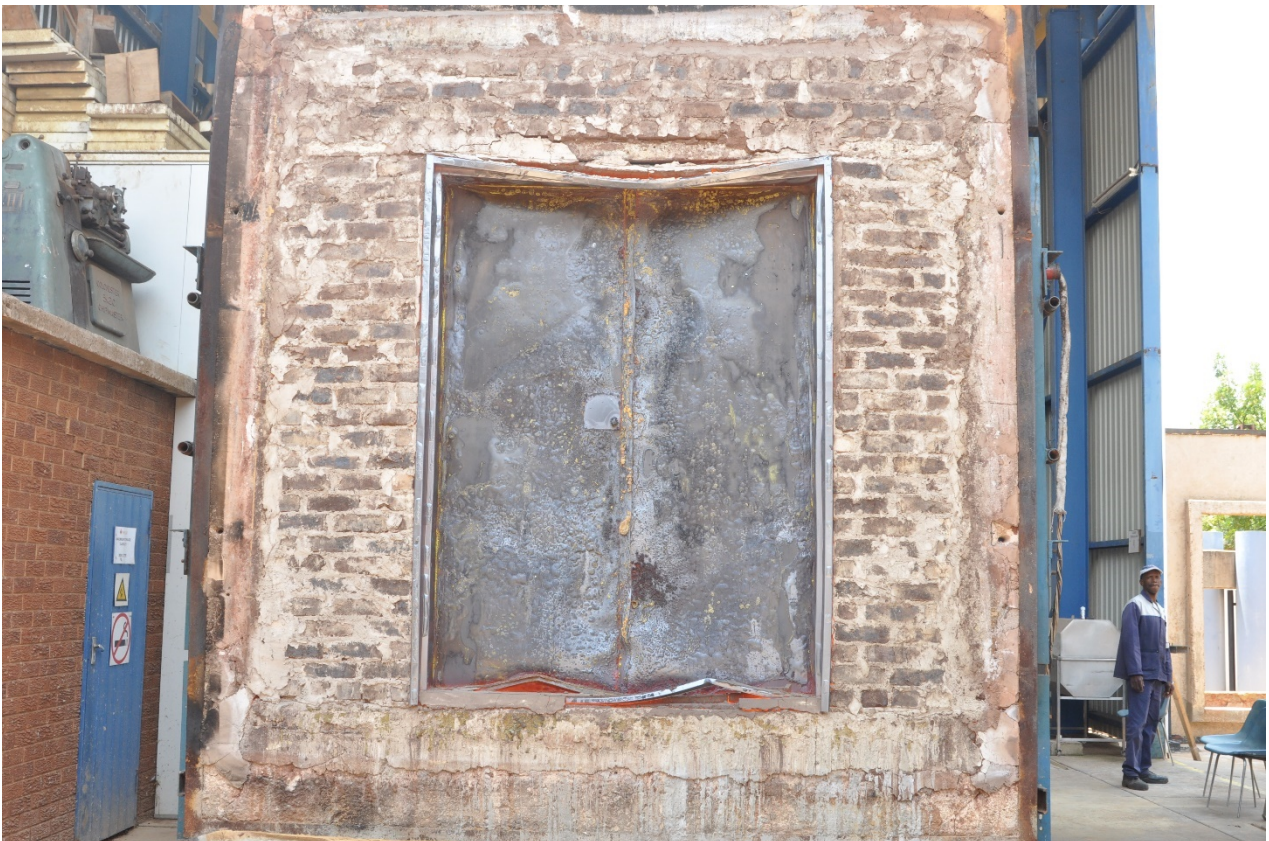
Figure 4.2.10: Exposed side of specimen at conclusion of the **Fire Resistance** test

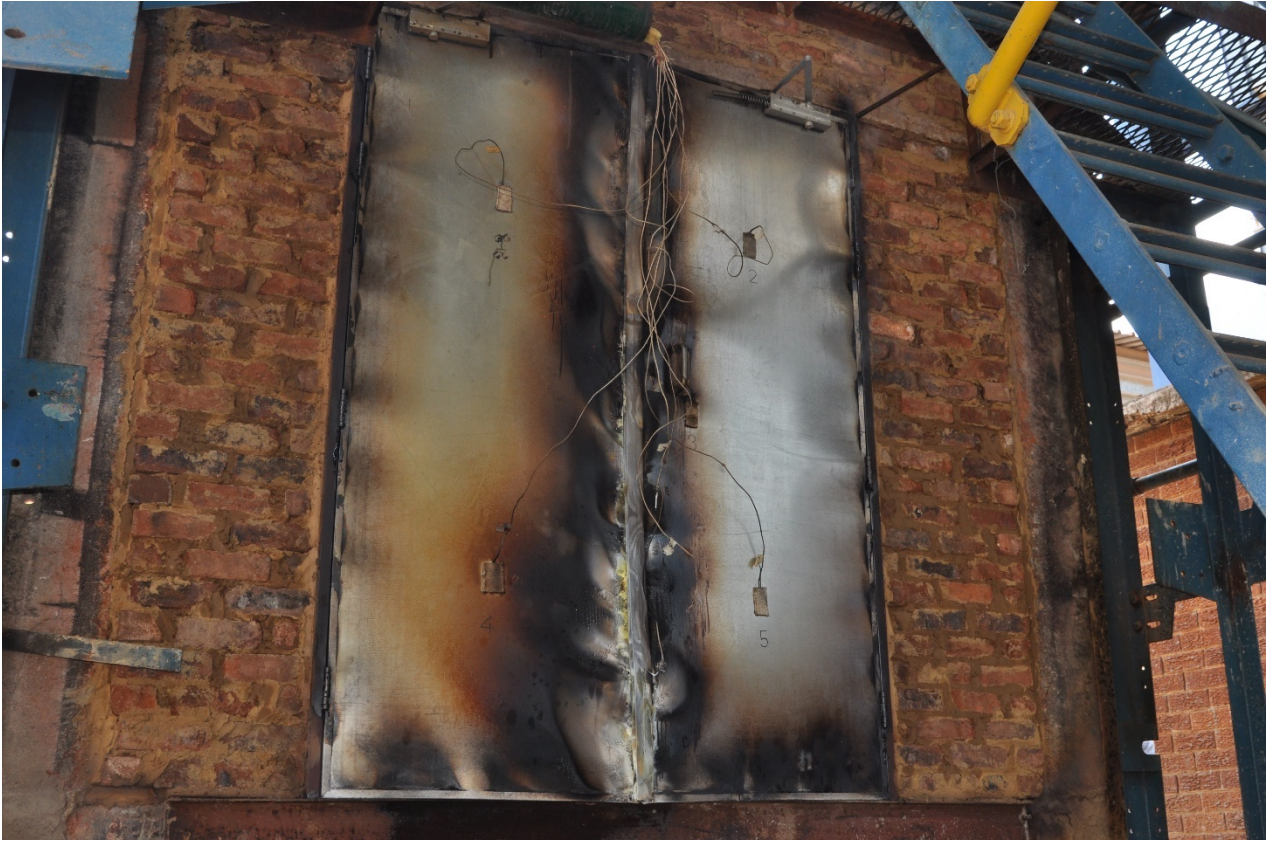
Figure 4.2.11: Unexposed side of specimen at conclusion of the **Fire Resistance** test

- **Stability (R):** Light gas flaming was observed. See the Discussion of results. The door stayed in place and was stable during the test.

The door tested had two 1,6 mm Masonite panels between the core and the steel cladding, which caused flammable gas to escape and cause flaming on the unexposed side.
