TITLE	:	Report on the evaluation of the proposed P&H Rocklite® Class F (452 x 652 Glazing) Fire Door assembly when classified in accordance with SANS 1253
REQUESTED BY	:	P&H Protective Plaster Systems (Pty) Ltd PO Box 11845 ASTON MANOR 1630
CONTRACT No	:	FTC 23/061
ISSUE No	:	1
DATE	:	01 September 2023

This report contains the evaluation of the proposed **P&H Rocklite® Class F (452 x 652 Glazing) Fire Door** when classified in accordance with **SANS 1253: Fire-doors and fire-shutters**.

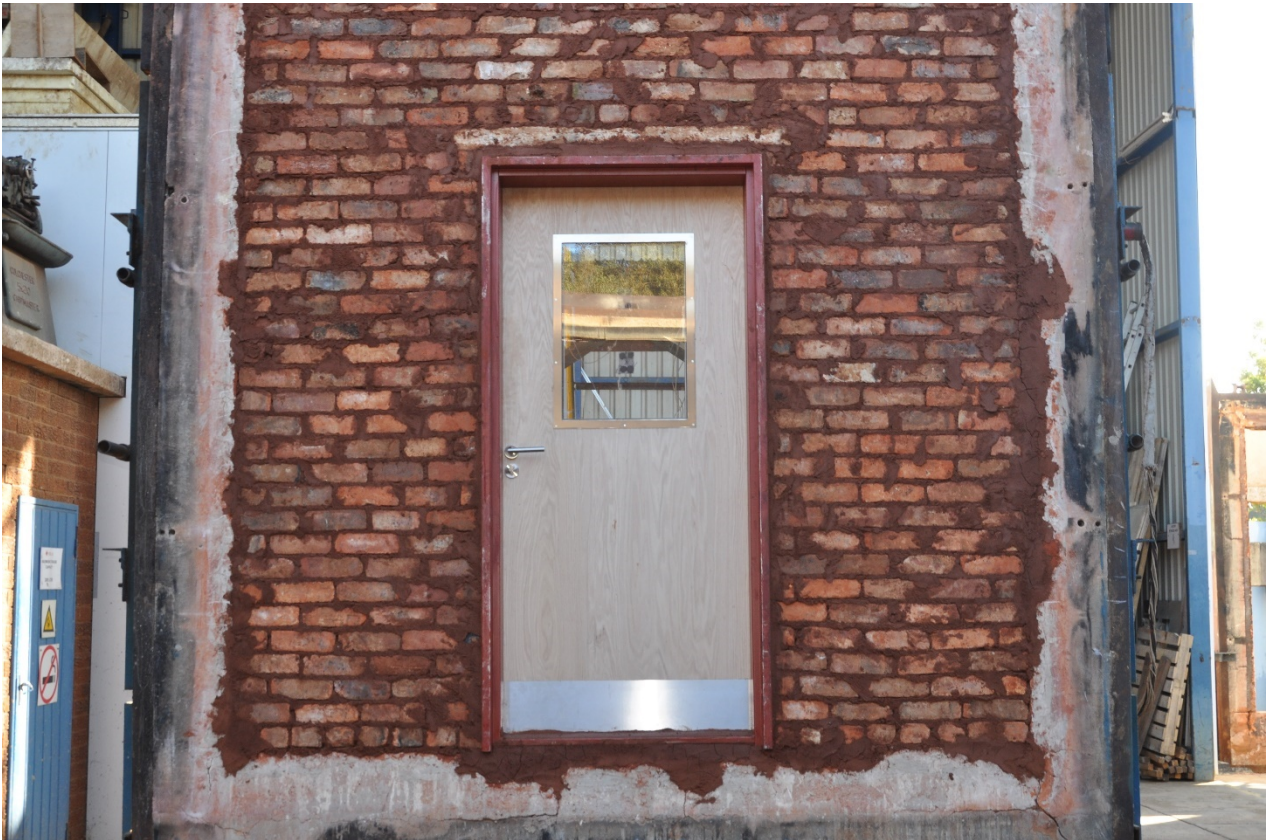
Figure 2.1: The 452 Glazed Door from the exposed side prior to the test

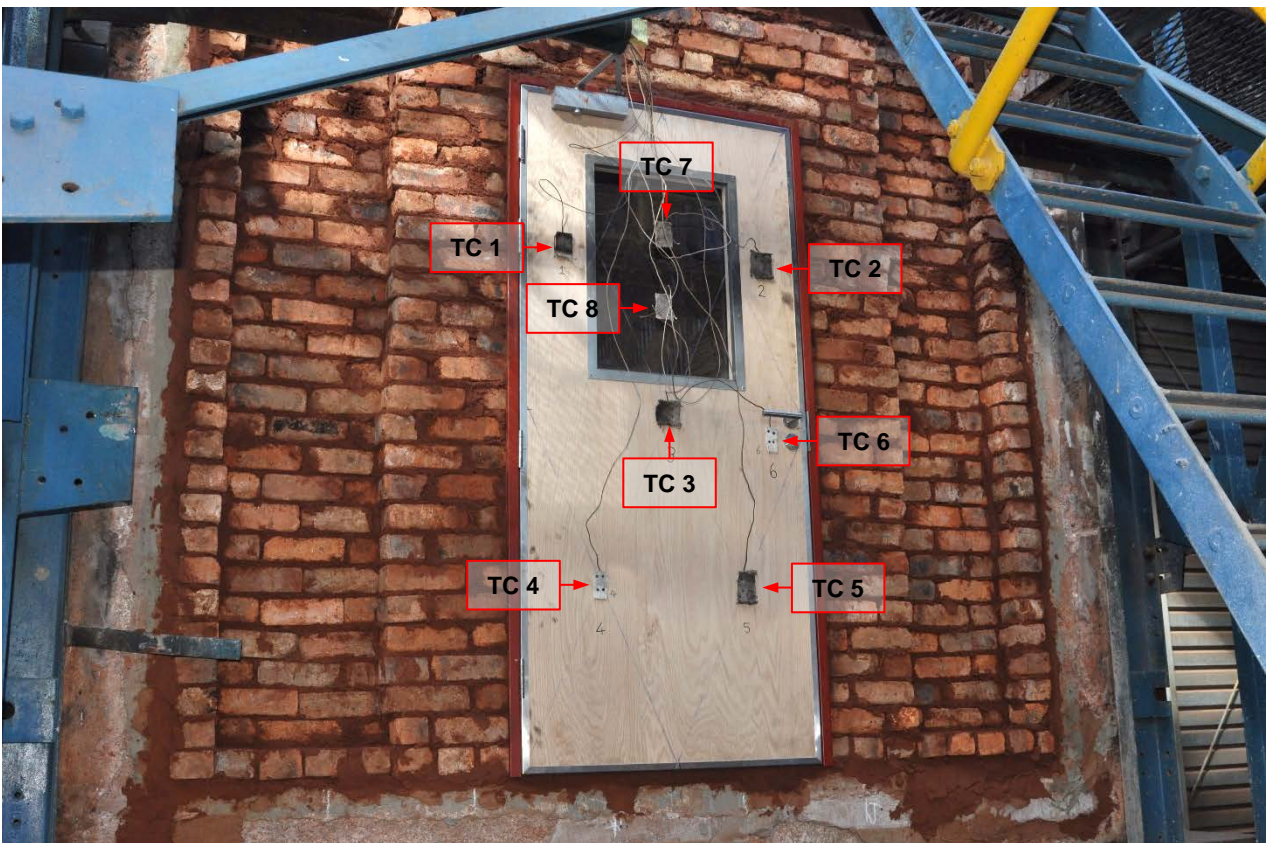
Figure 2.2: The 452 Glazed Door with thermocouples from the unexposed side

The **Insulation** criteria of the door specimen were measured using 5 thermocouples (TC 1 – TC 5) placed in a grid of equal area. TC 7 and 8 were placed on the glazing. TC 6 was placed near the lockset for additional information. The positions of the thermocouples are shown in Figure 2.2.

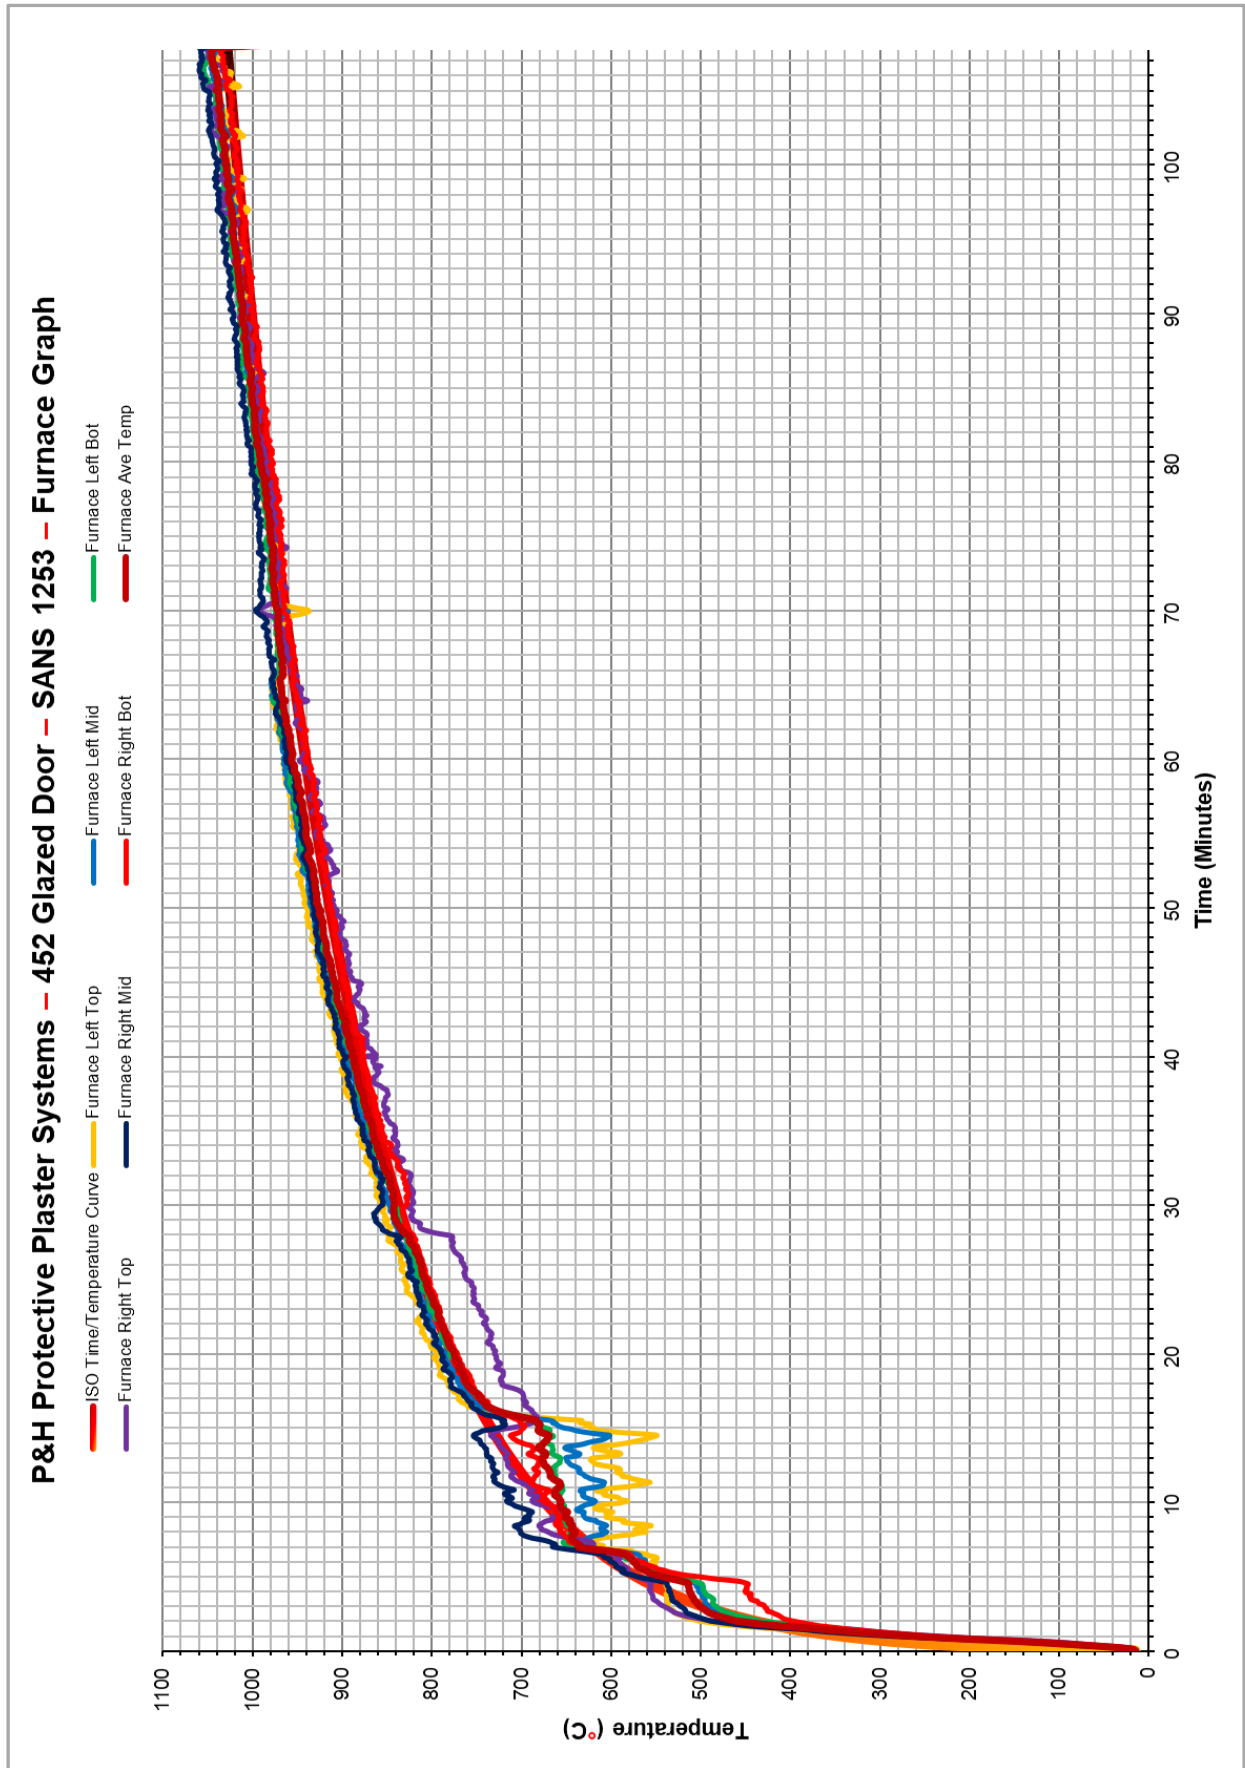
Figure 4.2.1: Furnace temperatures recorded during the large-scale FR test

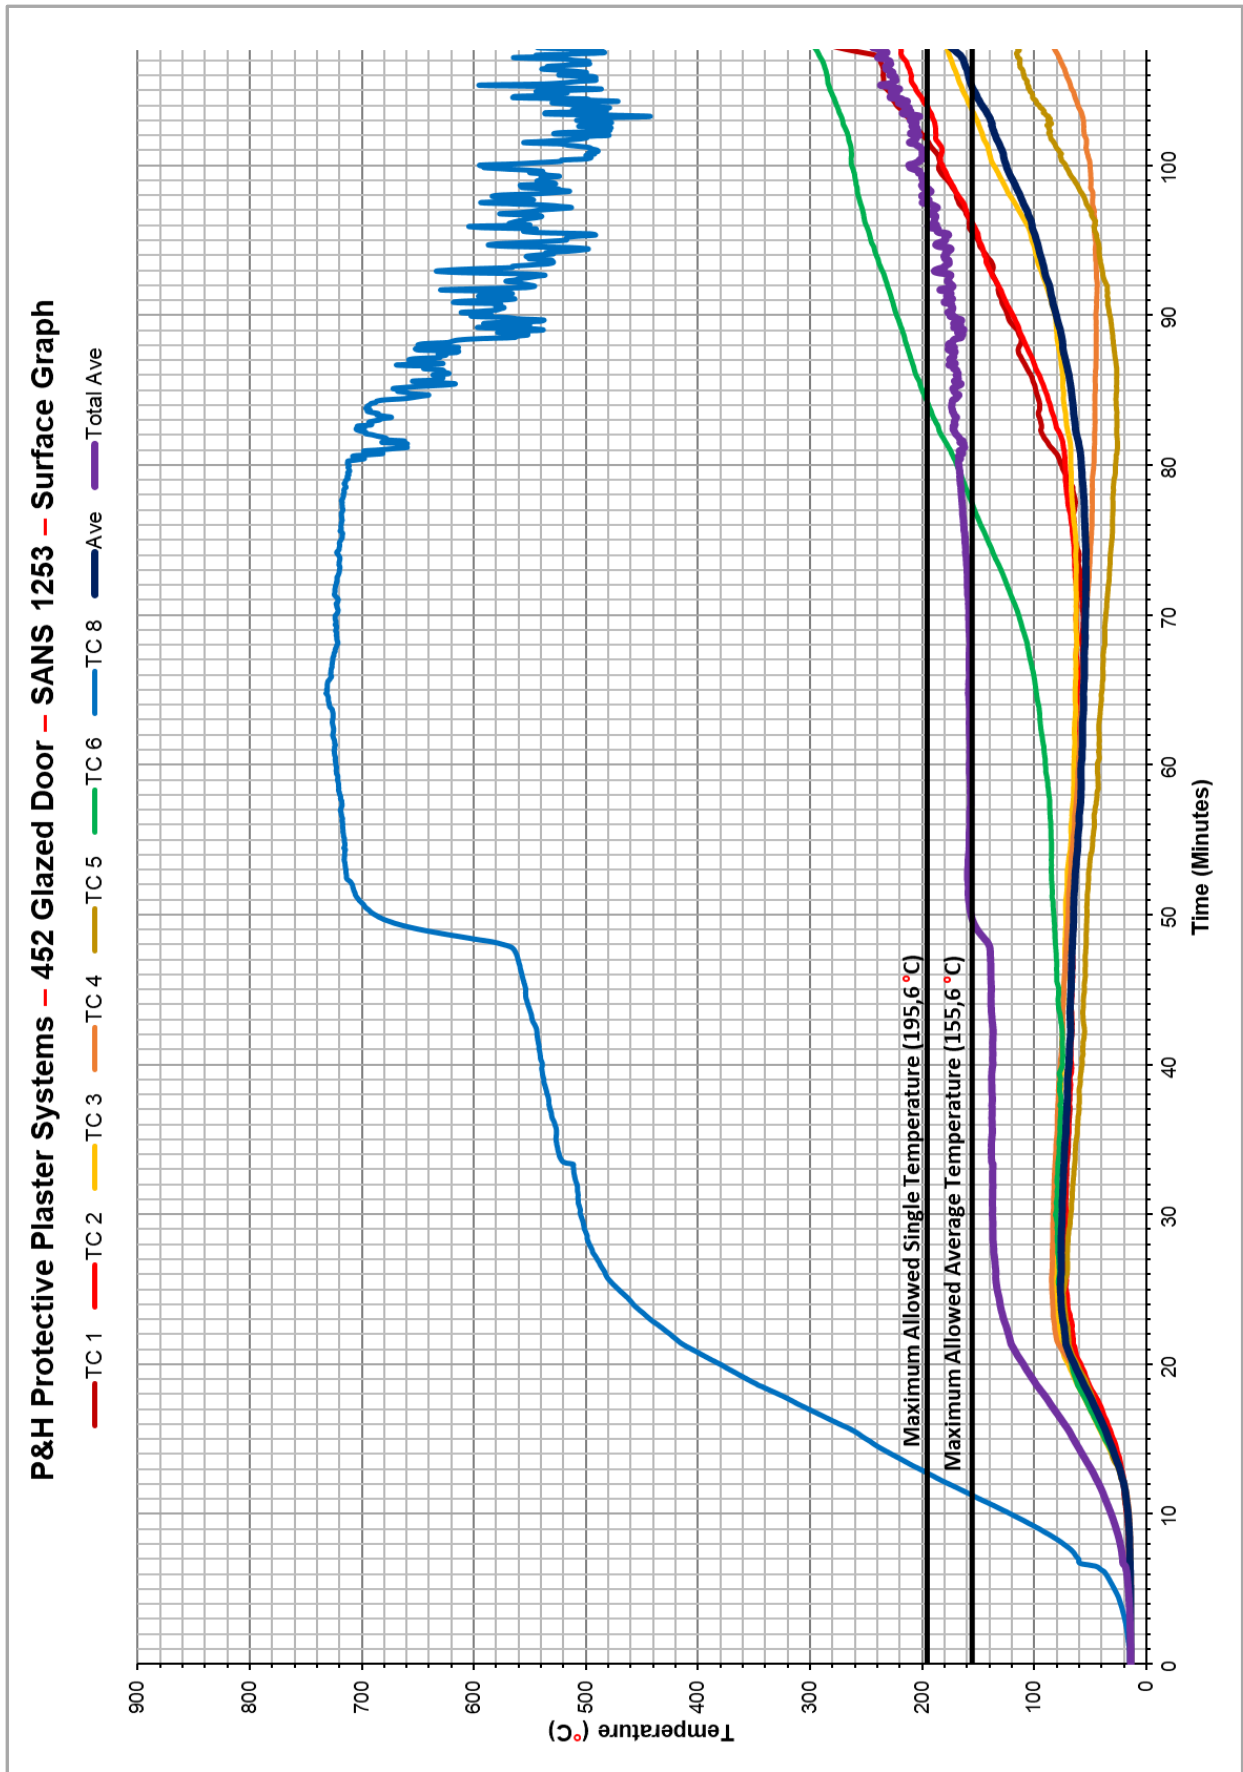
During the test, TC 7 malfunctioned. Its data has thus been removed from the graph.

Figure 4.2.2: Temperatures recorded on the surface of the specimen
